Nomination Category: Remediation of Contamination Impacting the Environment or Human Health

Project Name: Casino Mine Reclamation Project

Project Location: Clear Creek County, Colorado

Casino Mine Reclamation Project-Clear Creek County, Colorado

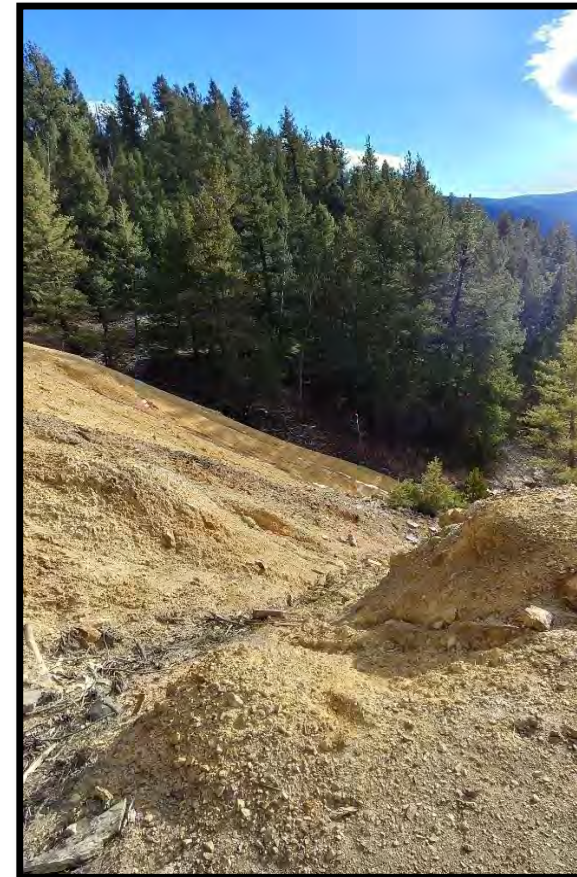
Photo # 2- Casino Mine Pre- Reclamation- Deep Erosion Gullies in Casino Waste Pile with High Concentrations of manganese, cadmium, copper and zinc

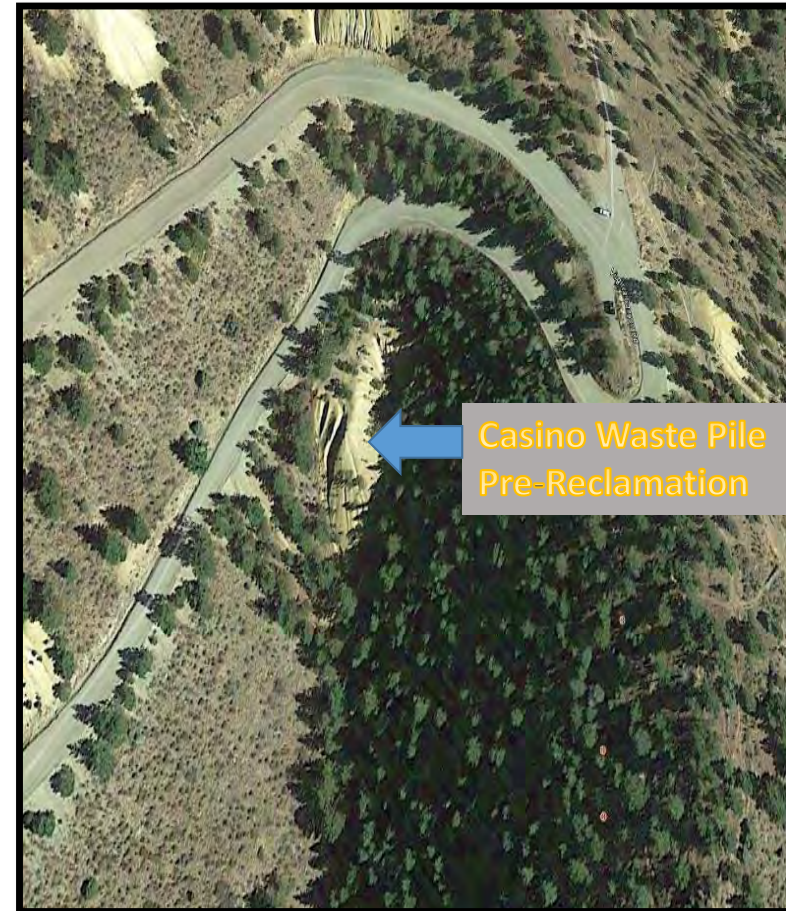
Figure #2- Casino Mine Pre-Reclamation\Access by Steep Unpaved Mountain Road. Steep incised gullies.

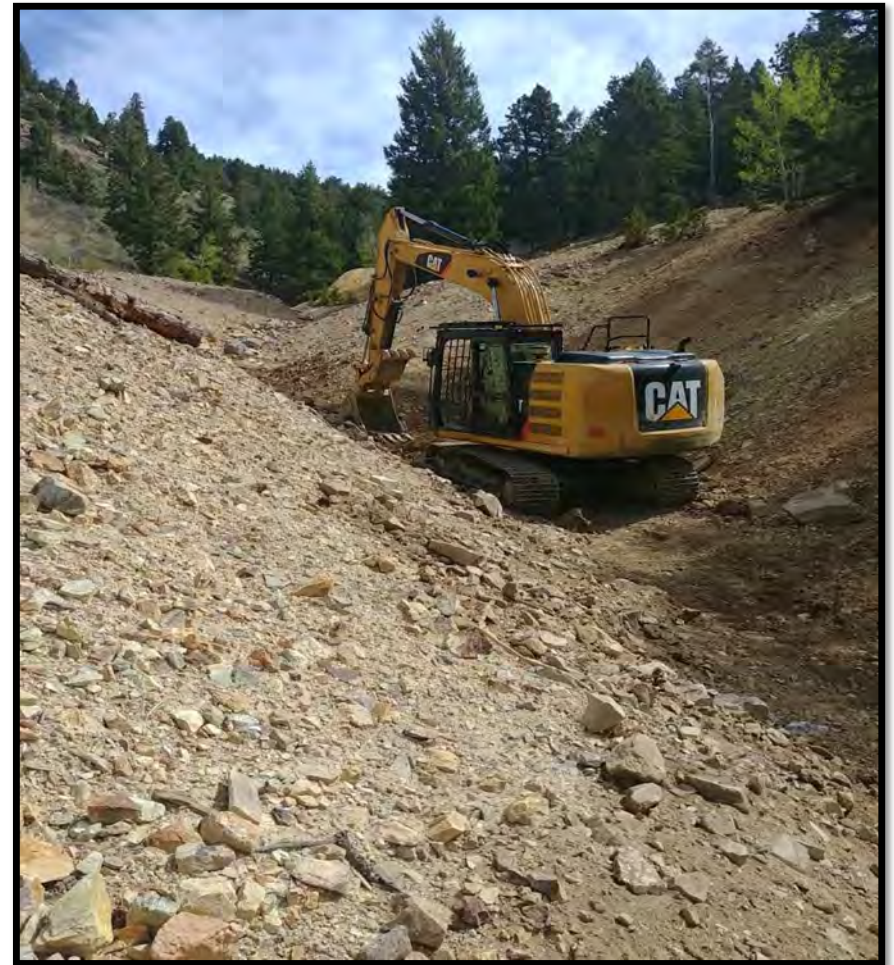
Photo # 3- Preparing Channel for Wall and Riprap. Over 3,000 cubic yards of material had to be excavated in order to expose bedrock. Rebar was drilled into bedrock in order to anchor the wall

The waste pile was excavated to expose bedrock along the channel to anchor the wall. Bedrock was located much deeper than planned and the location of the wall footer had to be modified resulting in increased excavation of material.

Two significant storm events destroyed the formwork for the wall footer also causing delays and cost increases. Eventually, rebar dowels were drilled into bedrock and the footer and wall forms were set. **(See drawing).**

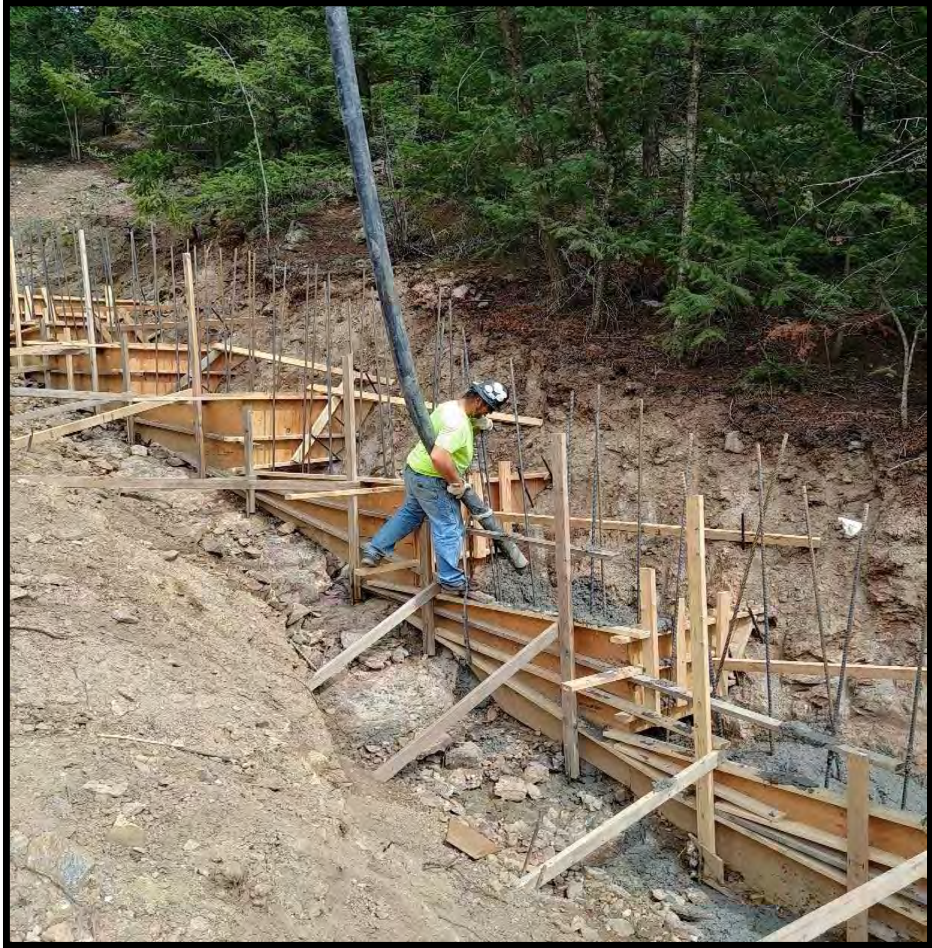
Photo # 4- Pouring Footer-Rebar Dowels Installed

The wall was poured in two phases. First, the footer for the wall was formed in a step configuration. This was necessary to accommodate the steep gradient of the channel. After the footer had cured, the wall was formed and poured. A total of one hundred thirteen cubic yards of 4500 psi concrete was used to construct the wall and footer. The wall is ninety feet long and eighteen inches wide. The height of the wall ranges from seven feet to twelve feet. The wall provides a physical barrier between the gulch and the mine waste. It also provides extra storage for mine waste.

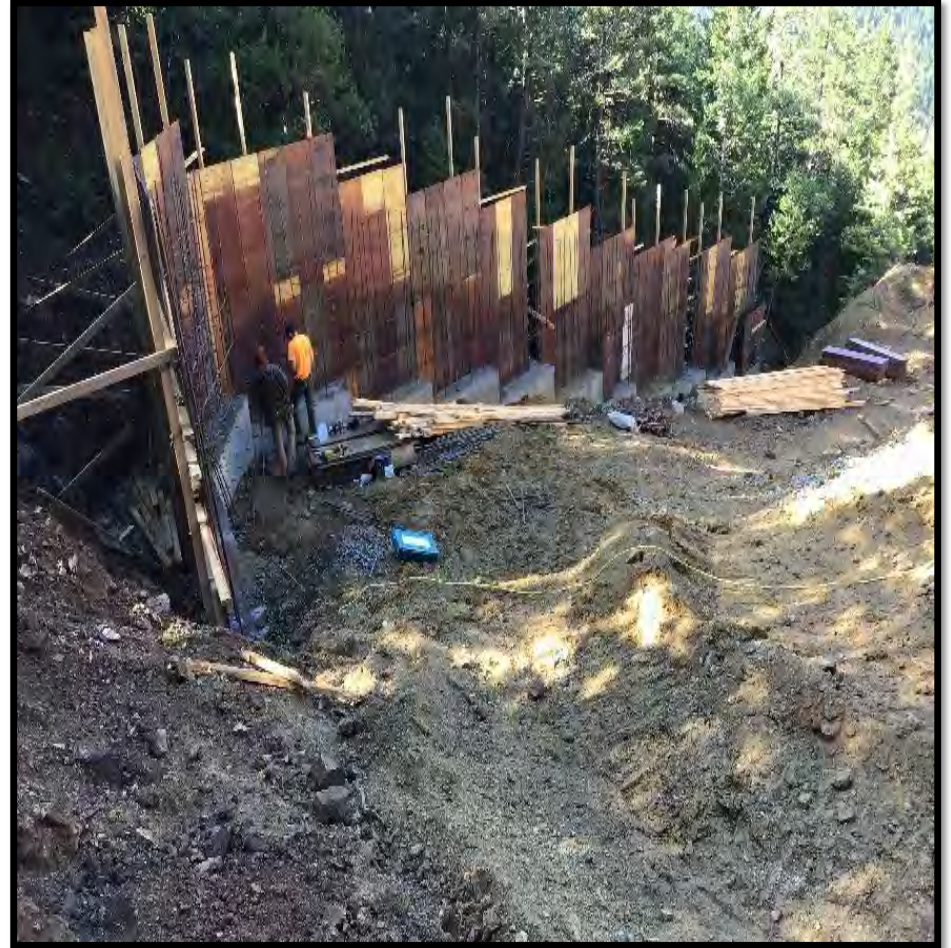
Photo # 5- Forming Wall

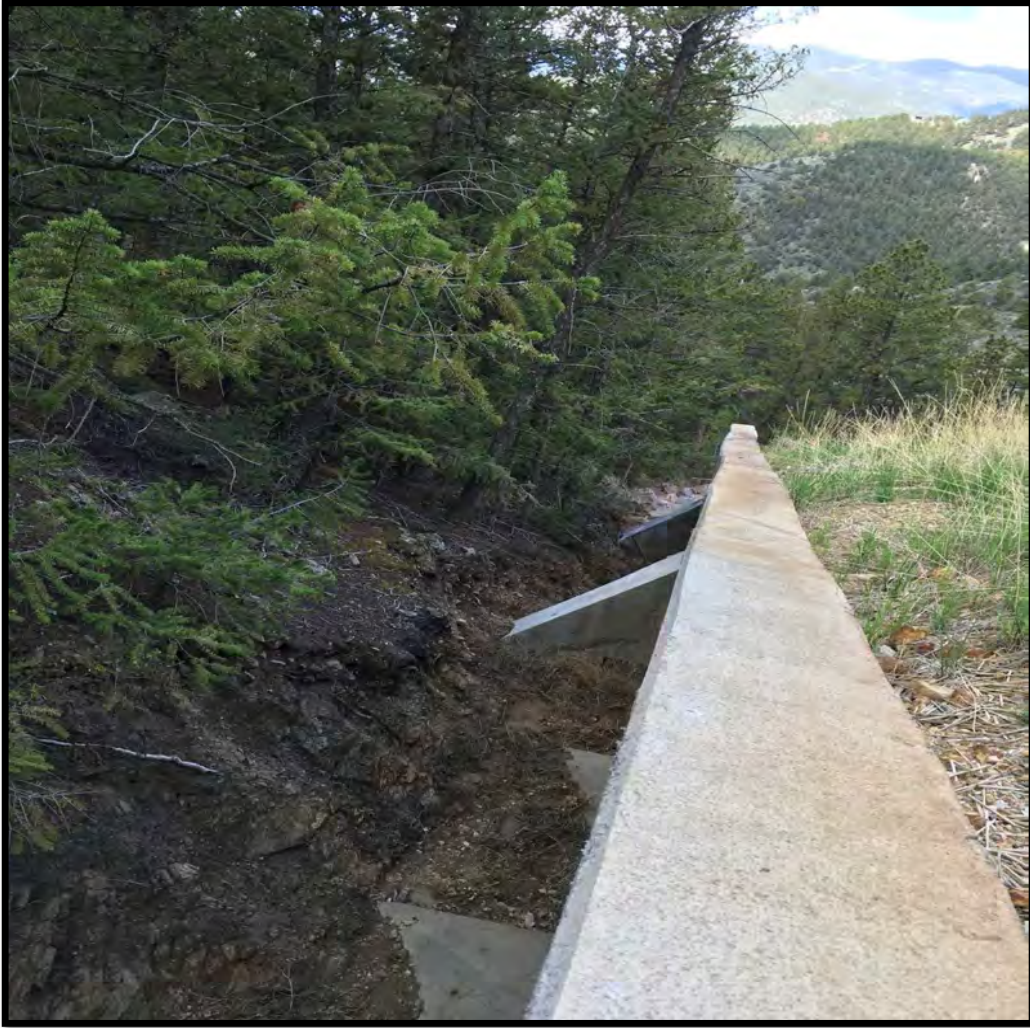
Photo # 6- Counterforts on Concrete Wall

Because the wall had to be relocated, it was necessary to increase the wall height in order to accommodate this change. Due to the increased height, three concrete counterforts were anchored into bedrock on the side of the channel to stabilize the wall. Four inch diameter perforated HDPE pipe was wrapped in Mirifi filter fabric, bedded in gravel and installed along the entire perimeter of the wall in order to relieve hydrostatic pressure between the wall and the waste pile.

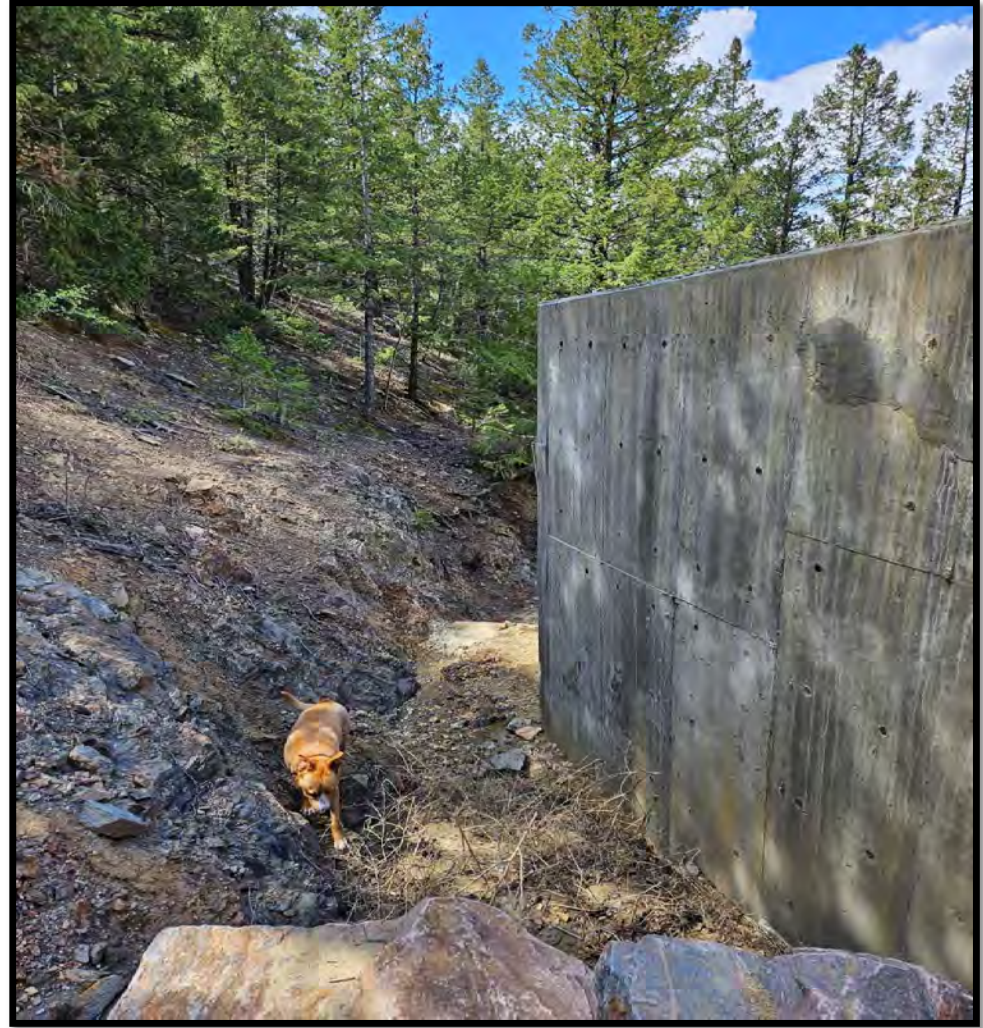
Photo # 7-Upper Concrete Wall Anchored in Bedrock

Ninety feet of concrete wall, ranging in height from 7 to 12 feet, was installed to provide a barrier between the mine waste and the channel. The wall was keyed into bedrock and provided a separation between the mine waste and flow in Seaton Gulch. The wall also provided extra storage for mine waste and allowed for a reduction in the gradient of the side slopes of the waste pile facilitating revegetation and providing slope stability.

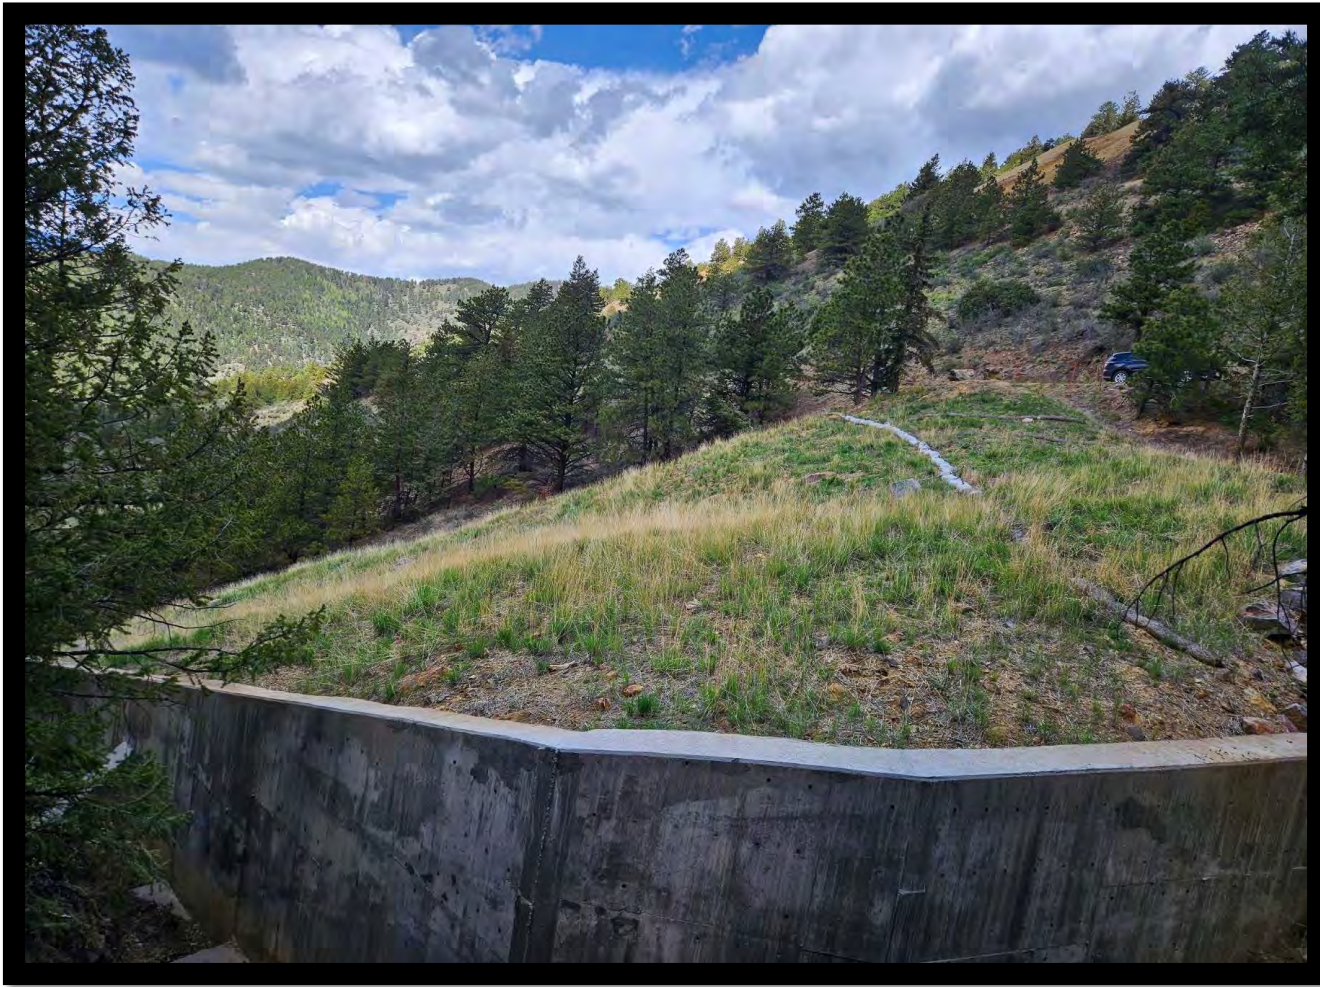
Photo # 8 - Concrete Wall Backfilled with Mine Waste and Revegetated- Over 18,000 Cubic Yards of Material Consolidated Behind Wall

Following completion and curing of the wall, mine waste was re-contoured and placed behind the wall. Prior to reclamation, the side slopes of the waste pile were almost vertical and contained deep gullies. The project work involved moving over eighteen thousand cubic yards of mine waste from the upper portion of the pile and consolidating it behind the concrete wall. The final grade of the majority of the waste pile is 2H:1V. In areas where the grade is steeper, large riprap was placed horizontally across the slope to reduce sheet flow and erosion. The grade conforms to the natural, pre-mining, topography of the area. **Because of the poor access and steep slopes, it was not feasible to use trucks or bulldozers to move the material. All material, over 18,000 cubic yards, was moved with the excavator and skid steer. The topography of the site could not accommodate a dump truck or dozer.**

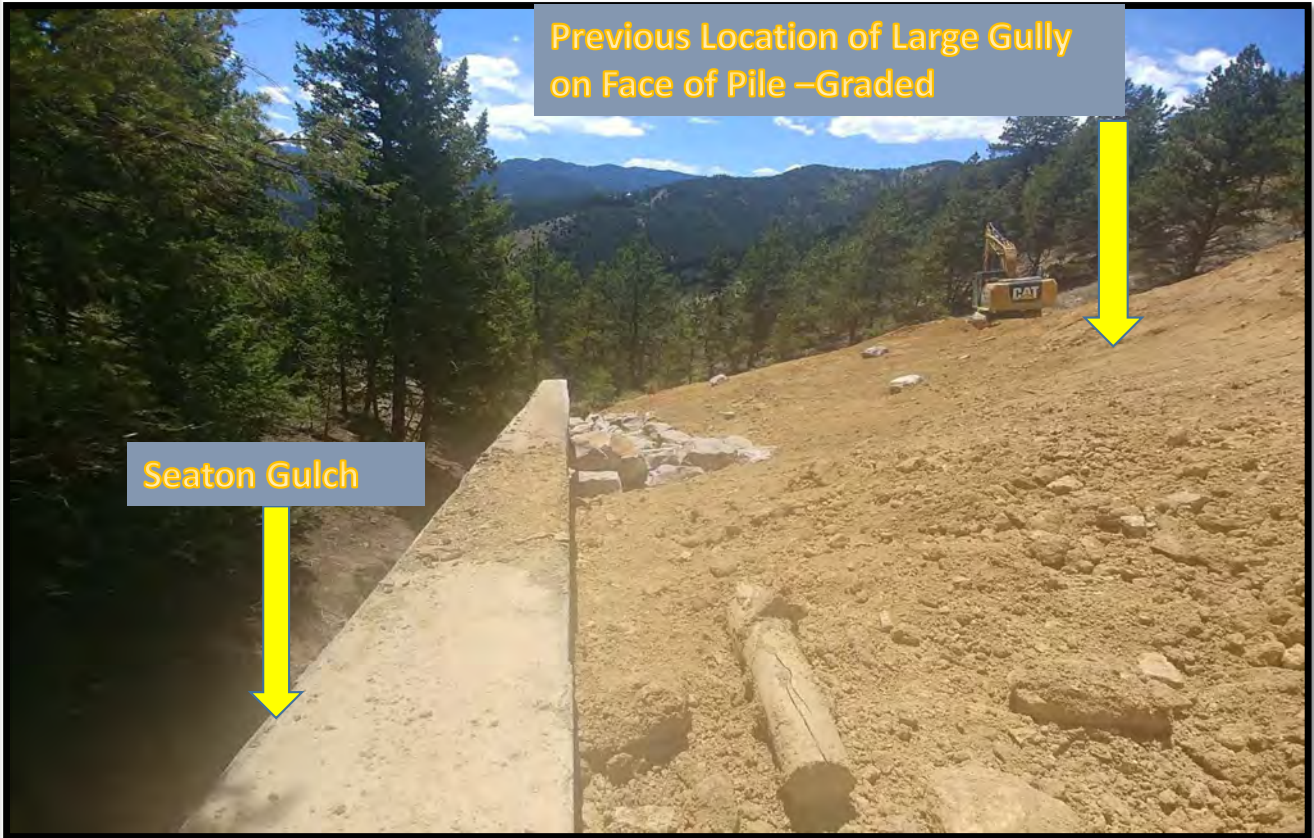
Photos # 9 and 10

(Left) Large Erosion Gully on Face of Pile.

(Above) Concrete Wall Provided Extra Storage for Mine Waste as Well as Physical Barrier Between Mine Waste Pile and Drainage.

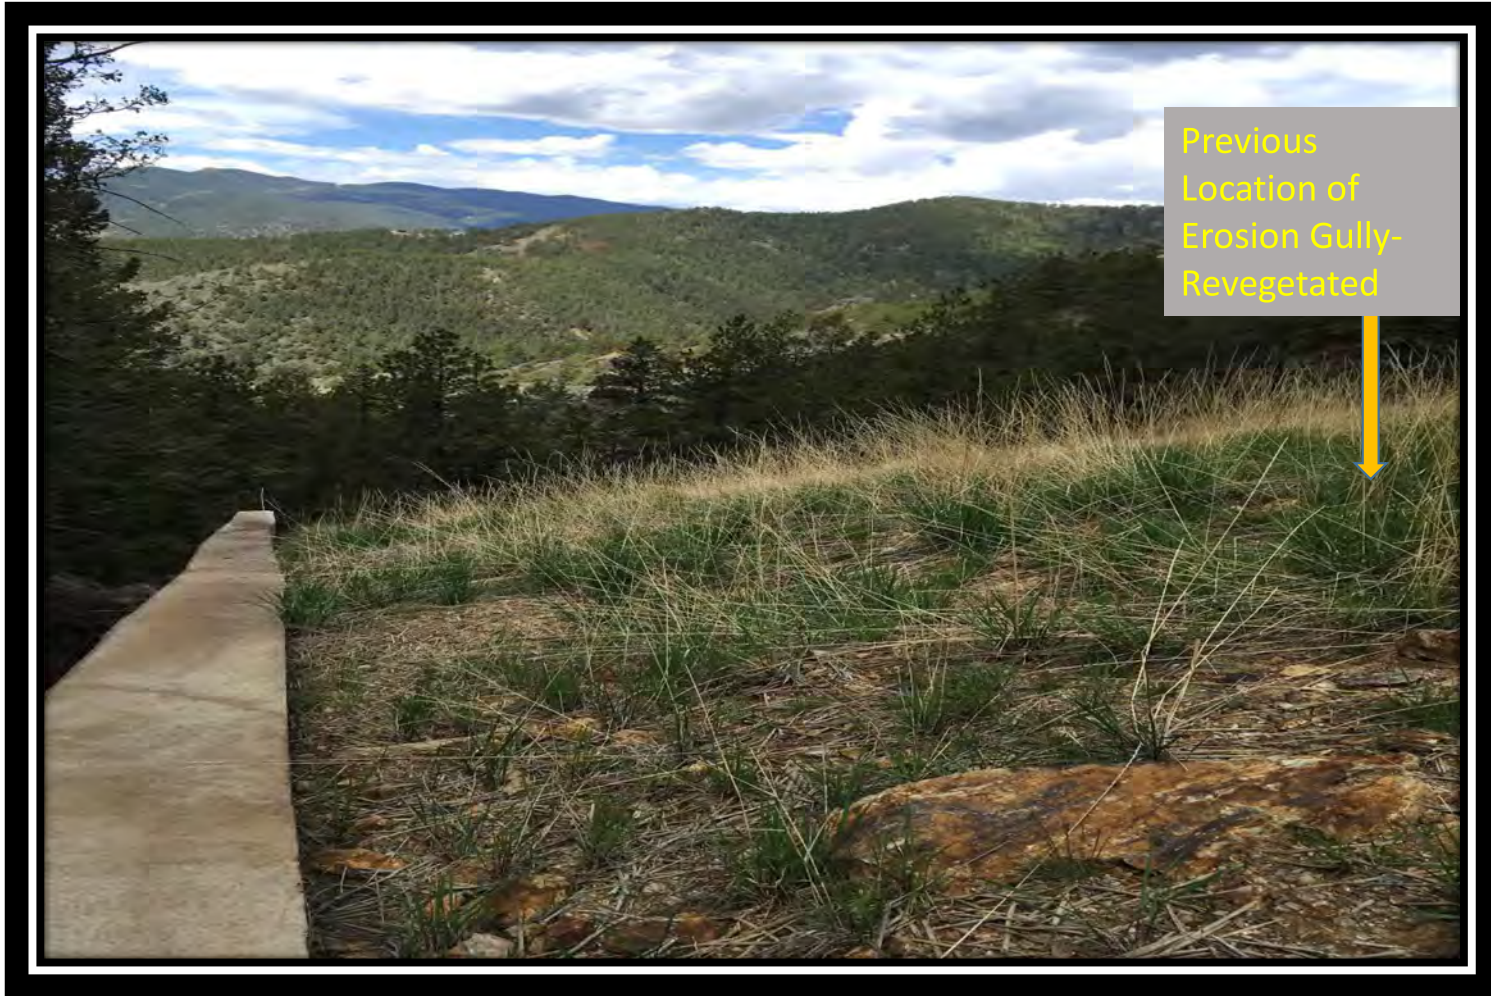
Photo # 11- Reclaimed and Revegetated Mine Waste

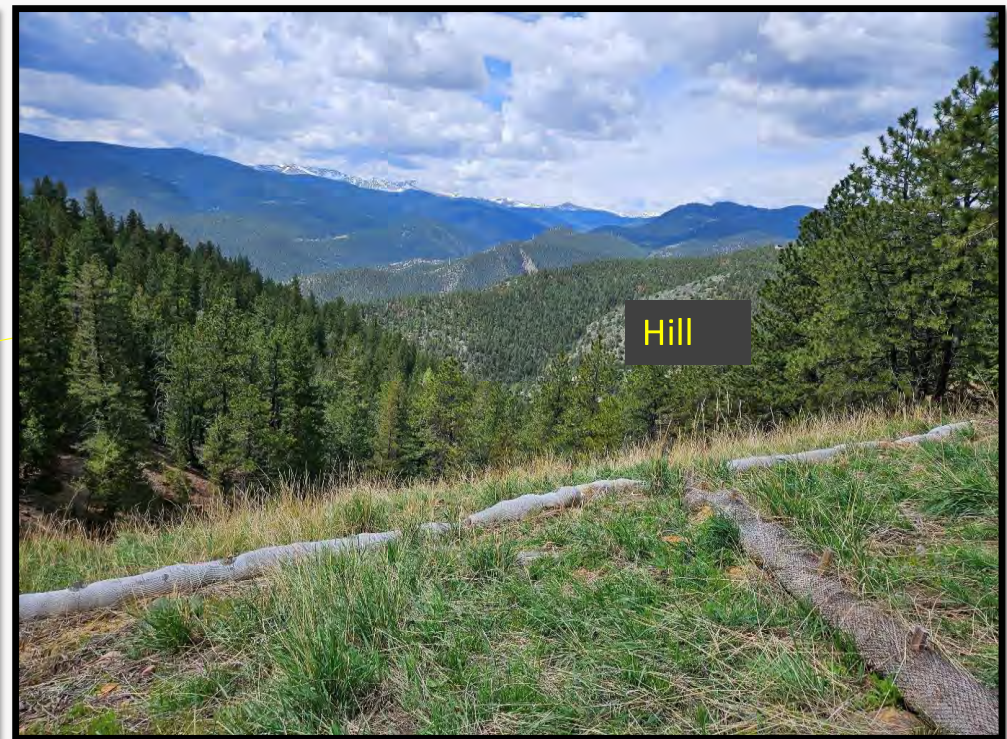
Photo # 13- Casino Waste Pile Post-Reclamation. The site was returned to the natural, pre-mining topography.

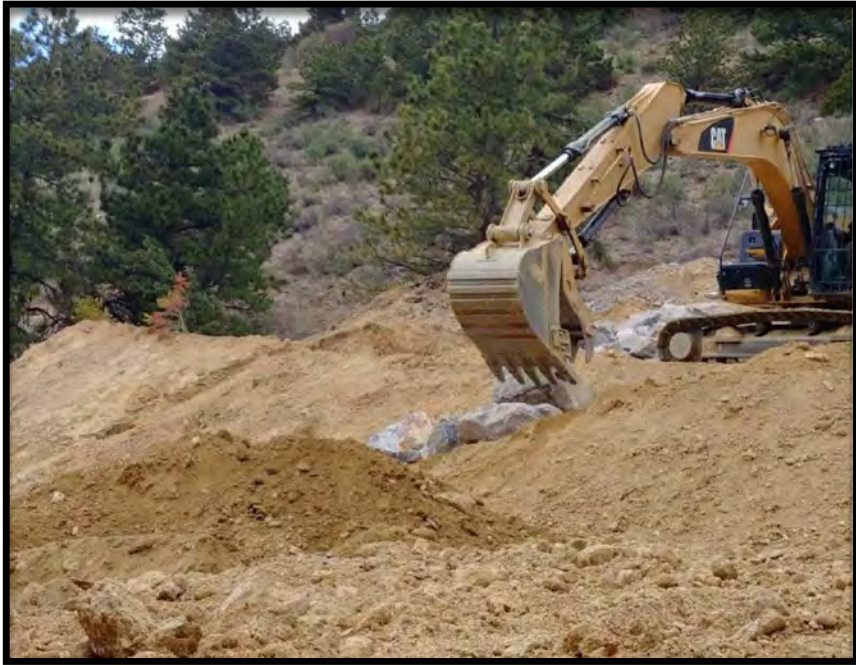
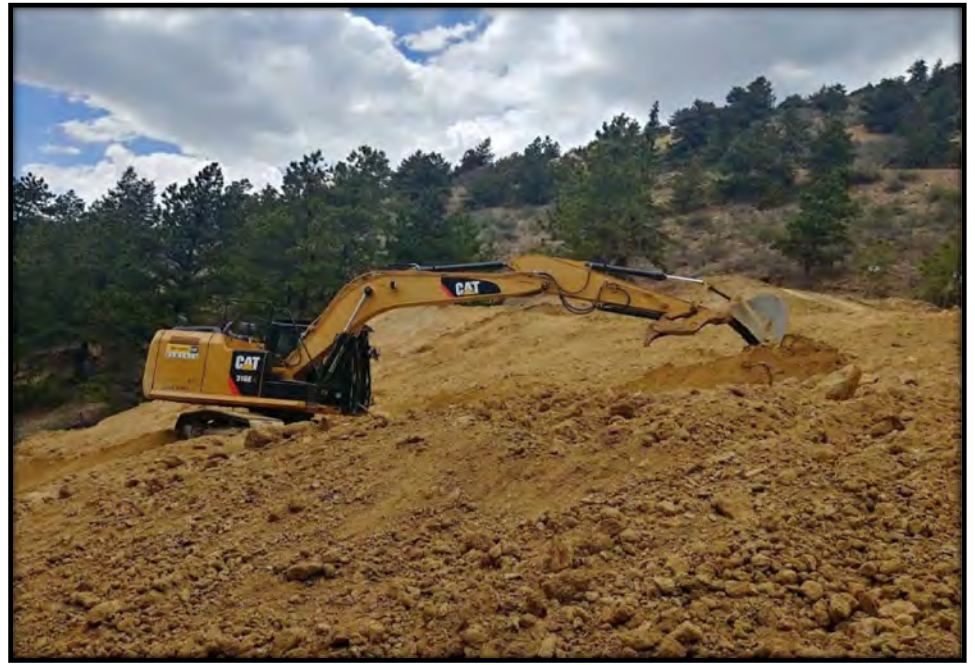
Photos # 14 and 15 -Transporting Material Downhill and Grading Waste Pile with Excavator. Grade was too steep for trucks and dozers. It took over 5 months to achieve the final grade using only a skid steer and excavator to transport and consolidate material.

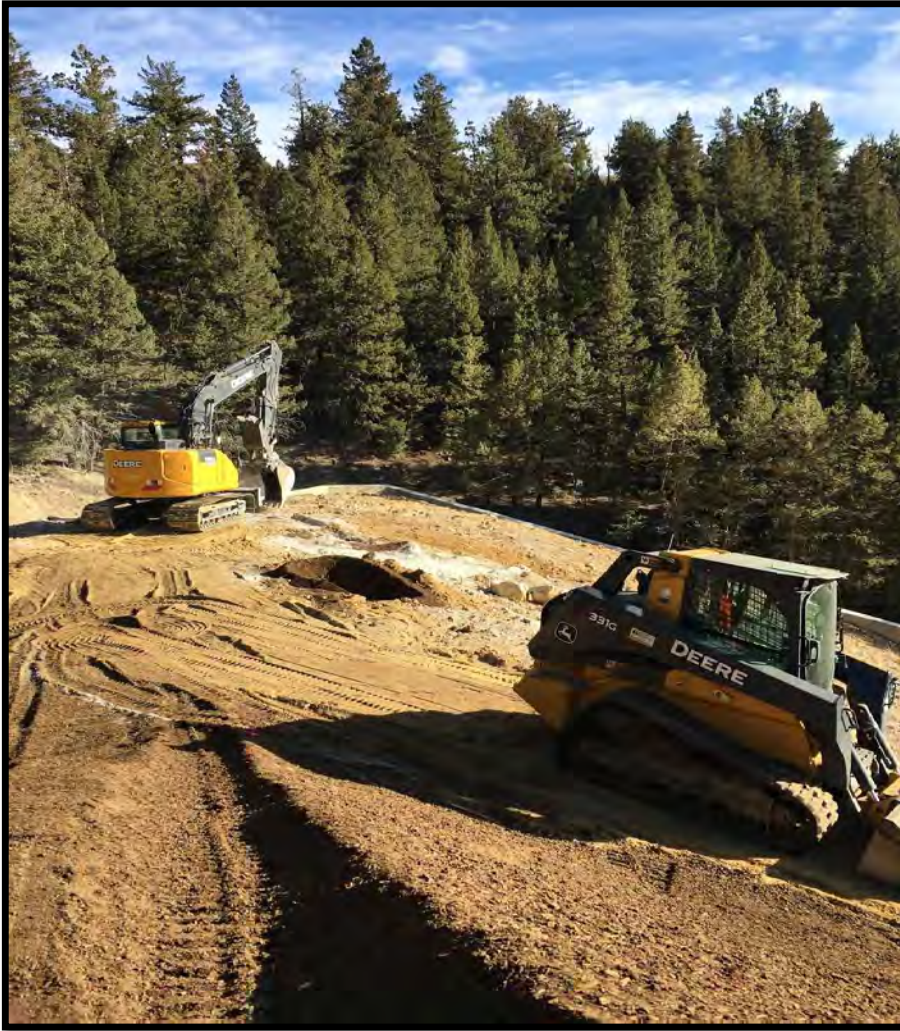
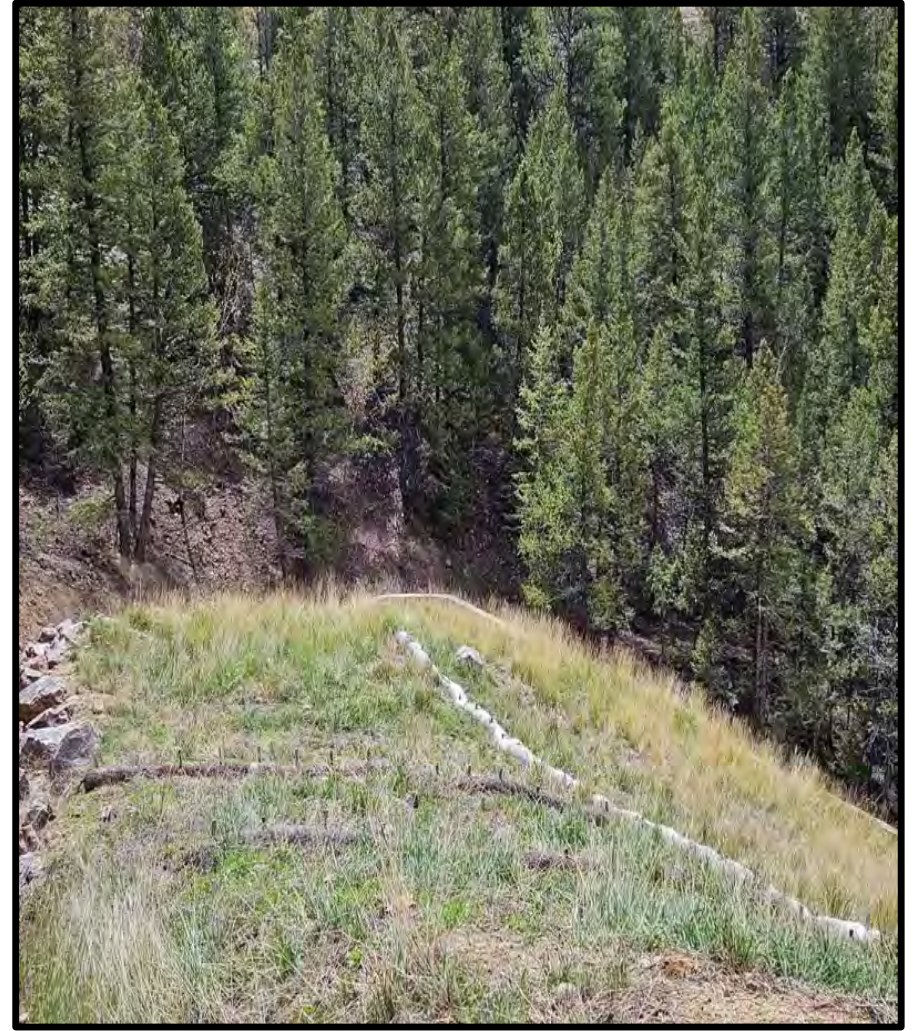
Photos # 16 & 17-(Left) Nearing Final Grade of Top Portion of Site (Right) Top Portion of Site-Post Reclamation

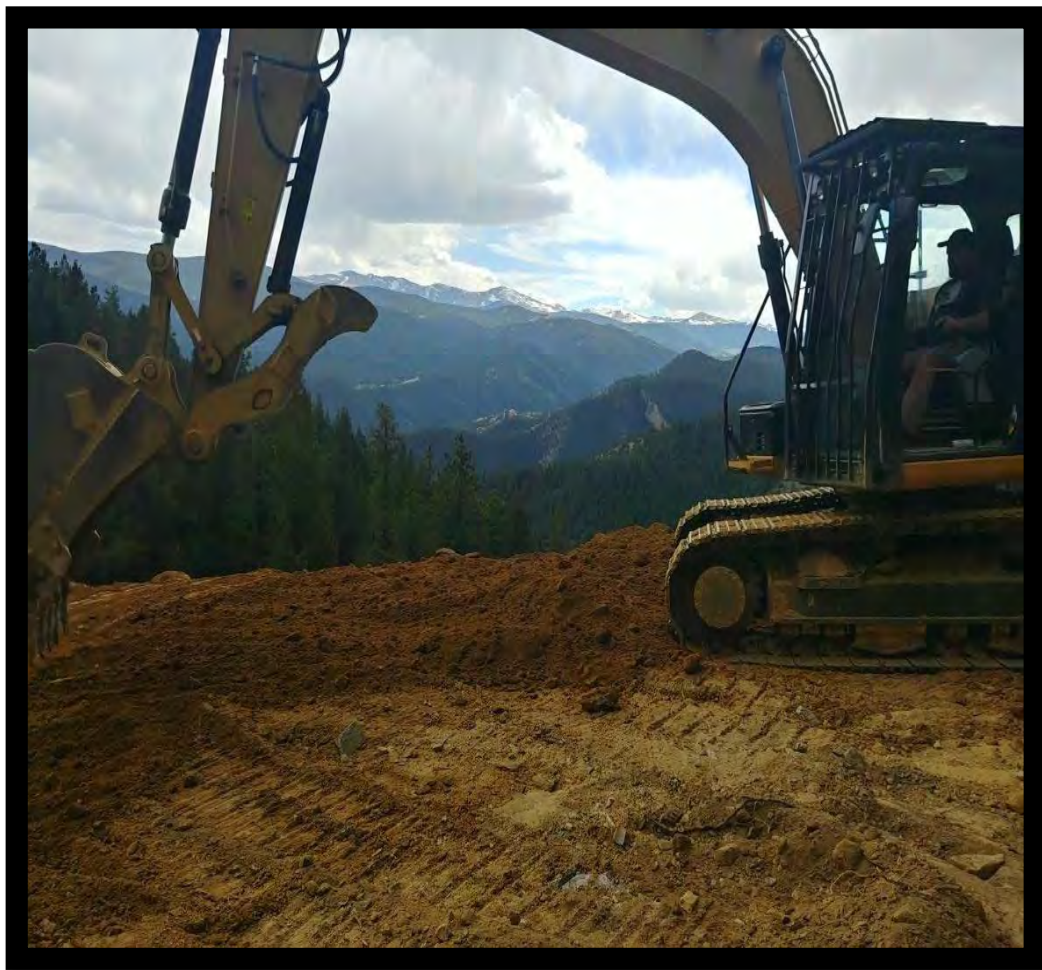
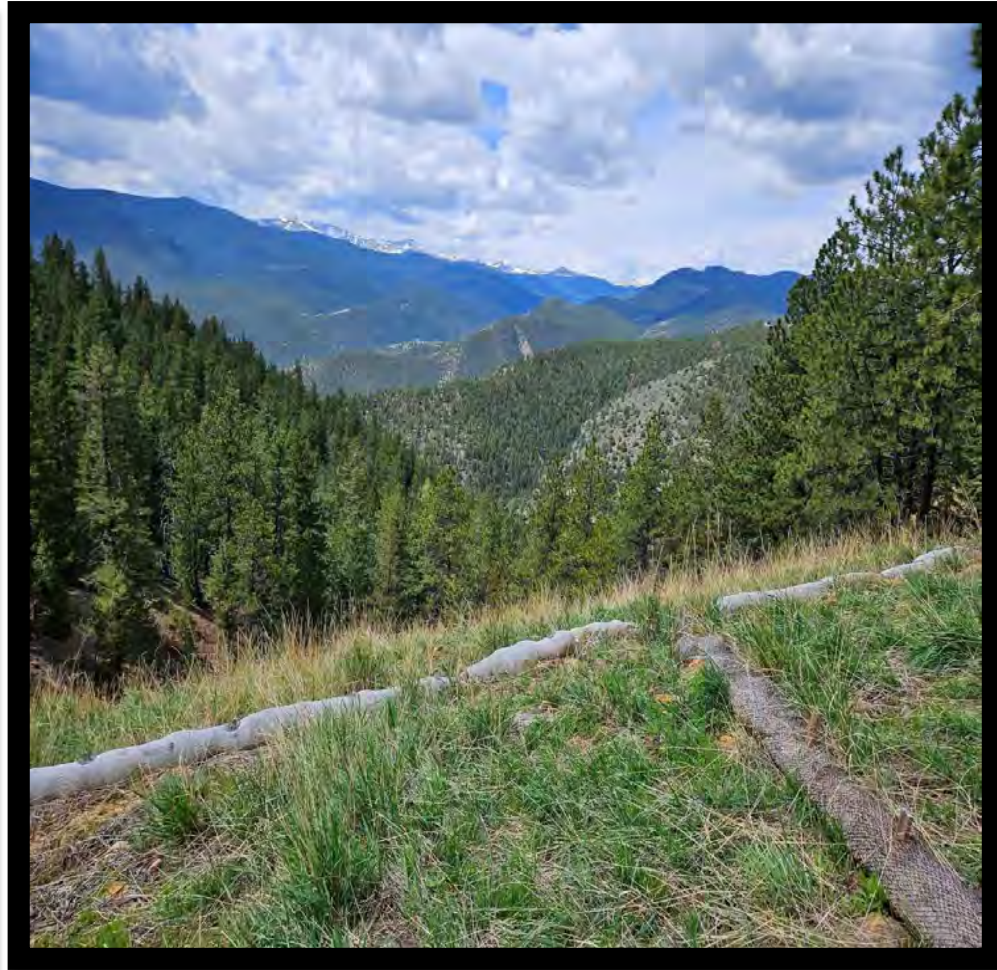
***Photo #18 (Left), Final Grade of Waste Pile-. Over 18,,000 cubic yards of material was cut from the top of the waste pile, transported downhill and re-contoured using an excavator and skid steer. It took over 5 months of construction to achieve the final grade.
Photo # 19 (Right)- 1.5 Year Post-Reclamation.***

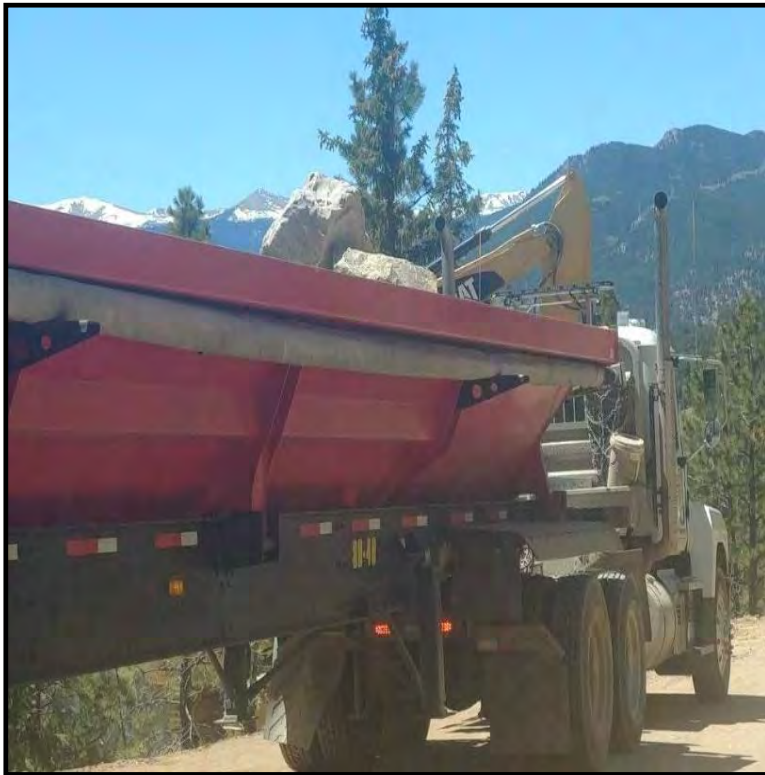
*(Left) Photo # 20
Delivery Truck Prior to
Dumping Boulders
Down the Slope
towards Project
Manager and
Operator*

Riprap was installed in portions of the channel above and below the wall. Approximately, two hundred linear feet of channel was lined with four foot diameter riprap. Also, boulders were placed on the slopes of the waste pile after the final grade was achieved to reduce erosion and provide microclimates for forbs and trees. A run-on diversion ditch was constructed to capture sheet flow from Virginia Canyon road. **Over two hundred twenty tons of riprap was installed on-site. Because of the difficult access, all riprap had to be transported and placed using an excavator. During the course of construction, the delivery truck driver carelessly dumped 4 foot diameter boulders down the slope on which the excavator was working. The project manager took cover behind the wall.**

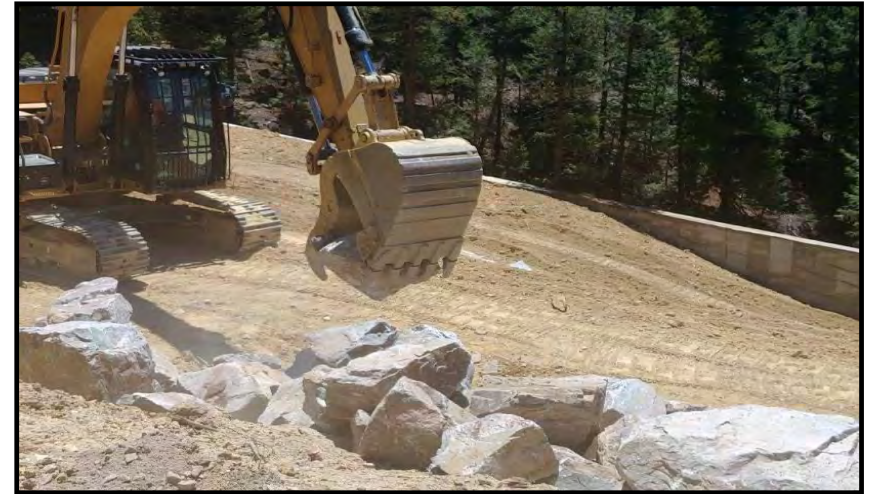
*(Upper Right) Photo
21, Placing Riprap
to Armor Ditch for
Erosion Control*

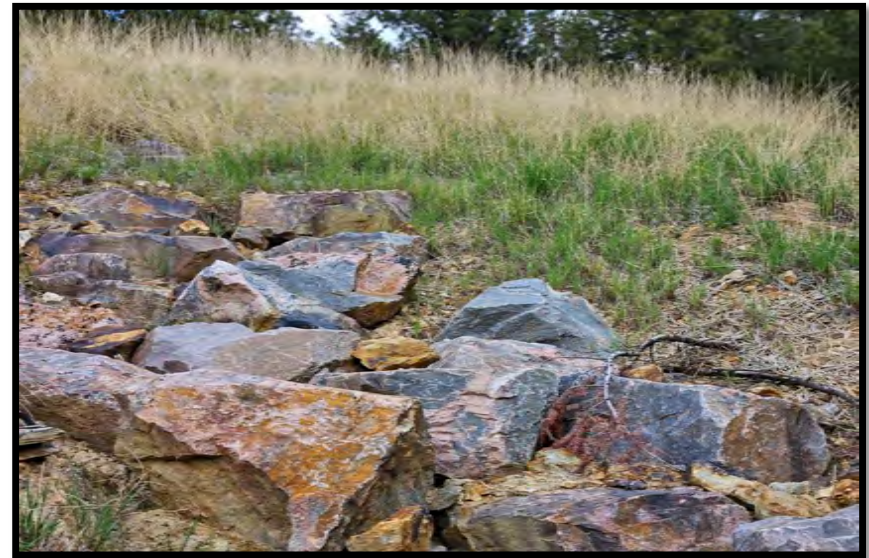
*(Lower Right) Photo #
22-Armored Ditch 1.5
Years Post-
Reclamation*

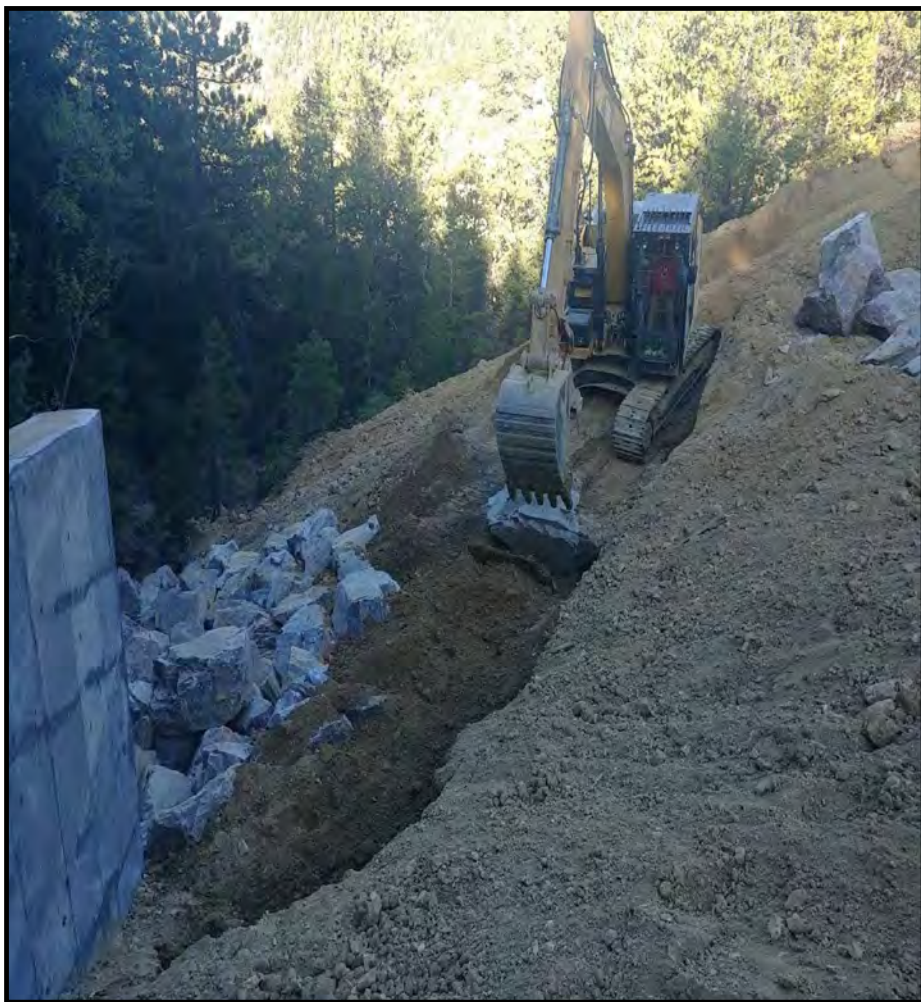
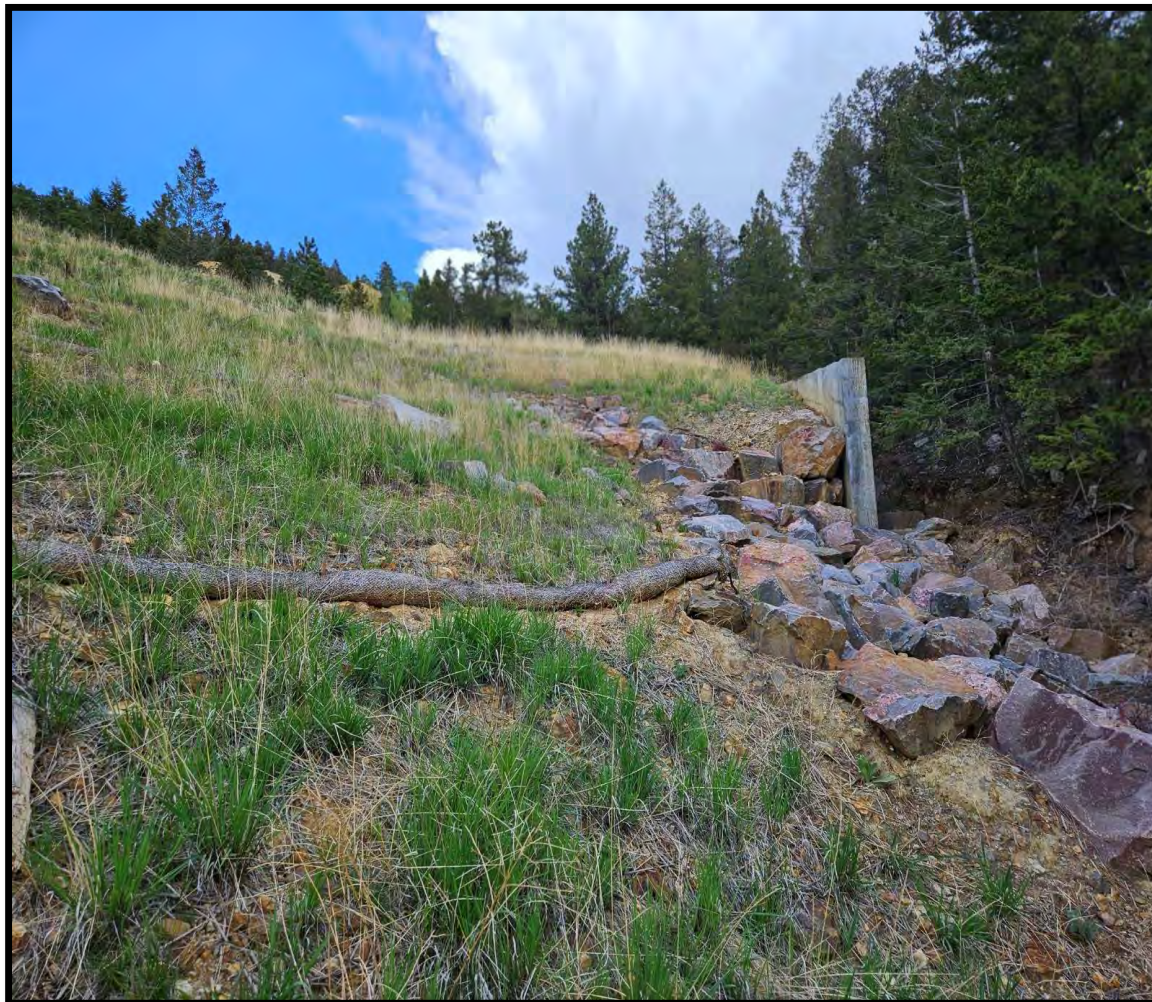
Photos # 23 & 24-Armored Lower Channel Pre and Post-Reclamation

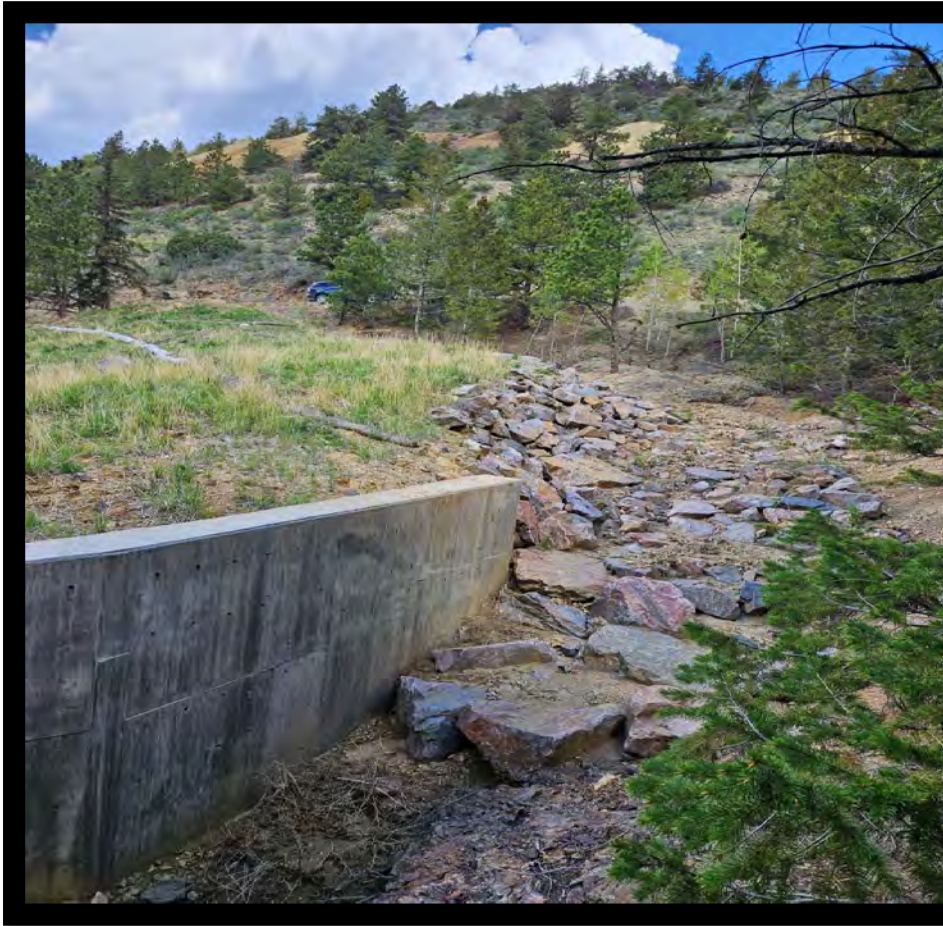
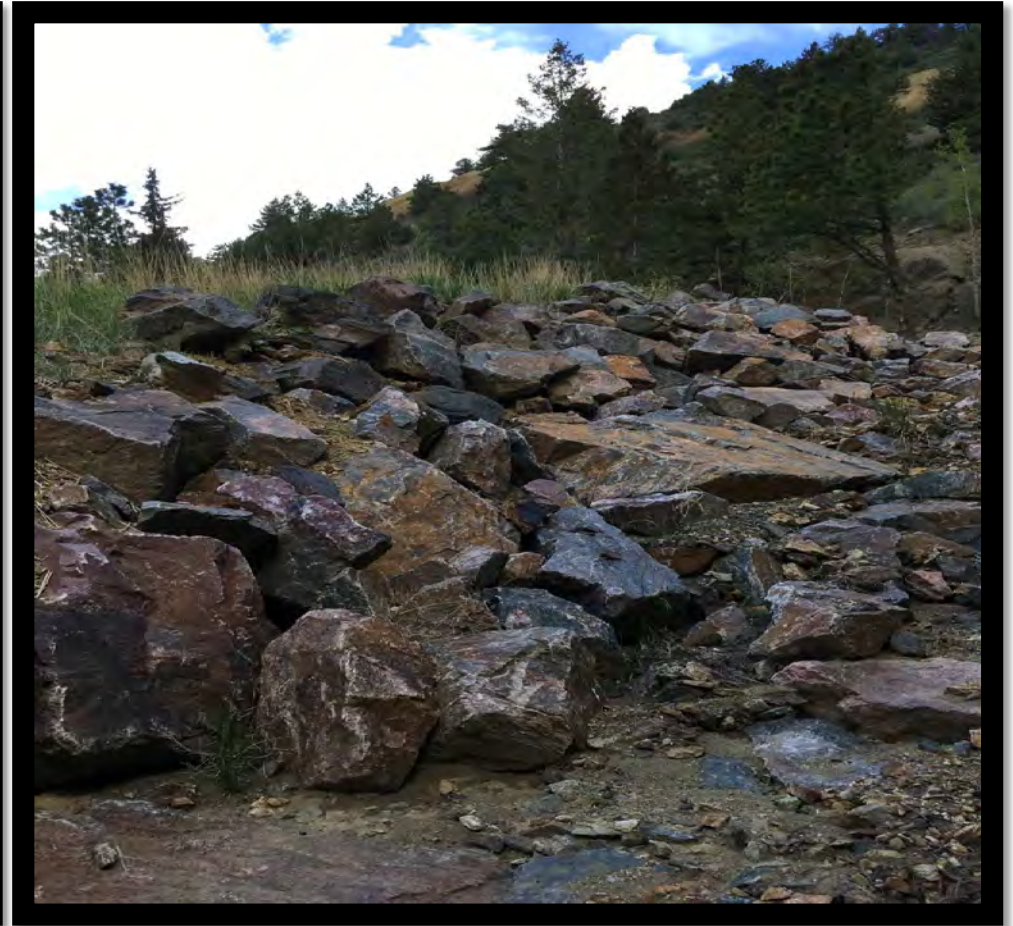
Photos # 25 & 26 -Upper Portion of Wall and Riprap in Channel. Landowner consent could not be obtained to continue the wall up the channel. Consequently, the mine waste had to be excavated from the channel and then armored with riprap. Over 220 tons of riprap were installed at the project site.

The original design included extending the wall along the entire interface of the waste pile and gulch. During construction, a landowner rescinded consent for the extension of the wall across his property. After much contention riprap was placed instead.
