Nomination Category: Remediation of Contamination Impacting the Environment or Human Health

Project Name: Casino Mine Reclamation Project

Project Location: Clear Creek County, Colorado

Casino Mine Reclamation Project-Clear Creek County, Colorado

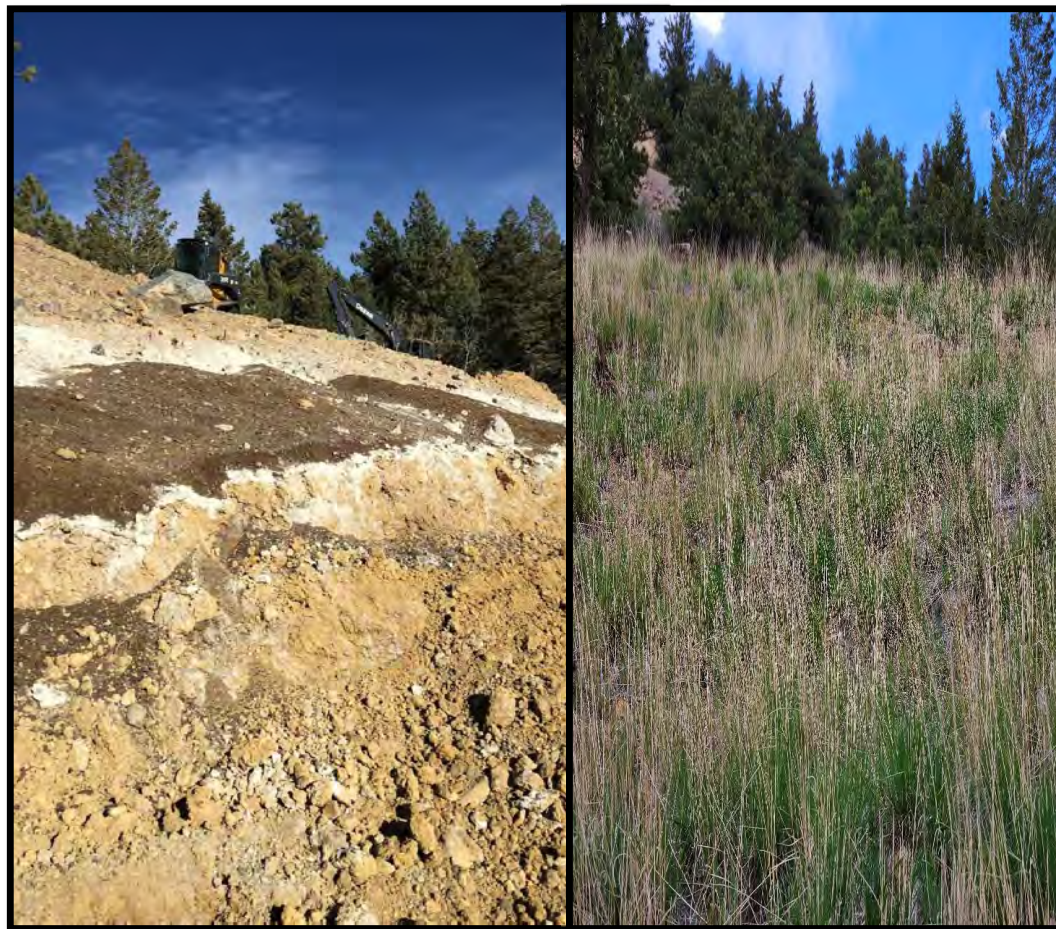
Photos # 27 & 28-Compost and Lime Applied to Mine Waste & Slope Post-Reclamation

The technique involved amending the mine waste with compost and lime. The mine waste was amended with pulverized limestone to raise the PH and compost was added to provide nutrients and organic material. The “recipe” had to be tailored to the Casino mine site as the mine waste had a very low PH. However, the technique was successful and **saved over \$80,000.**

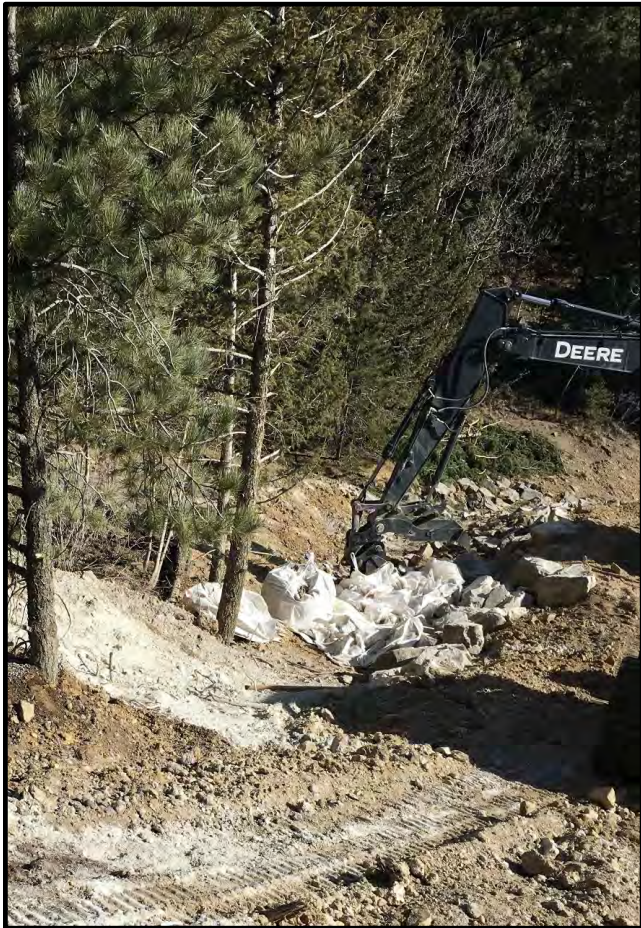
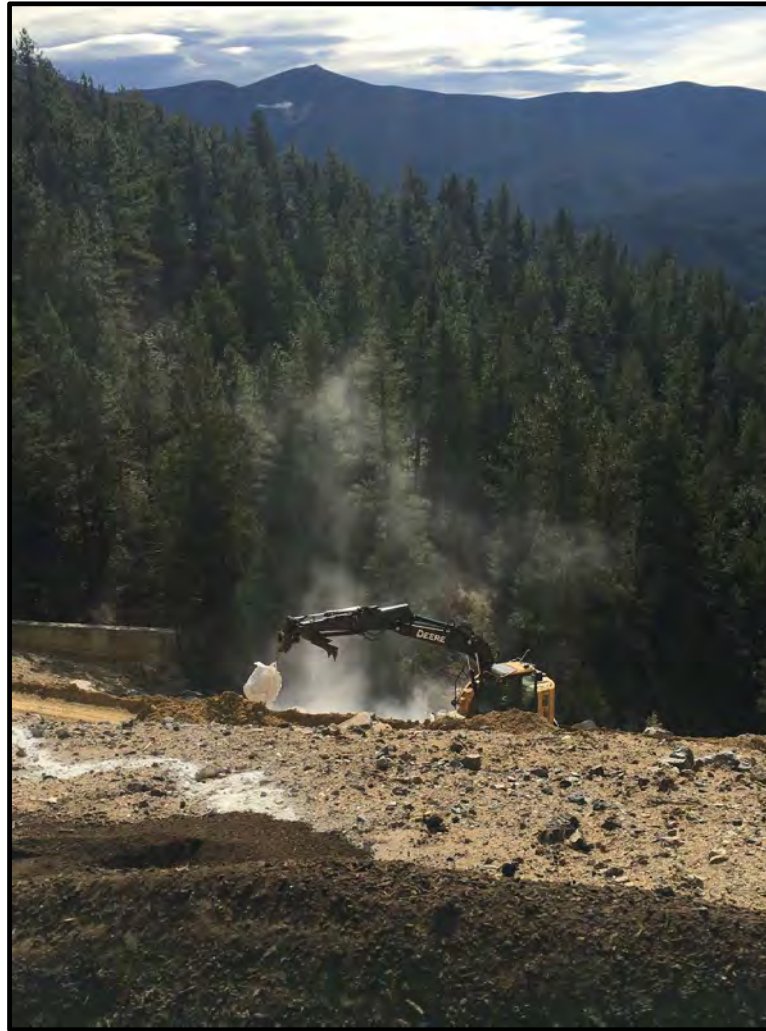
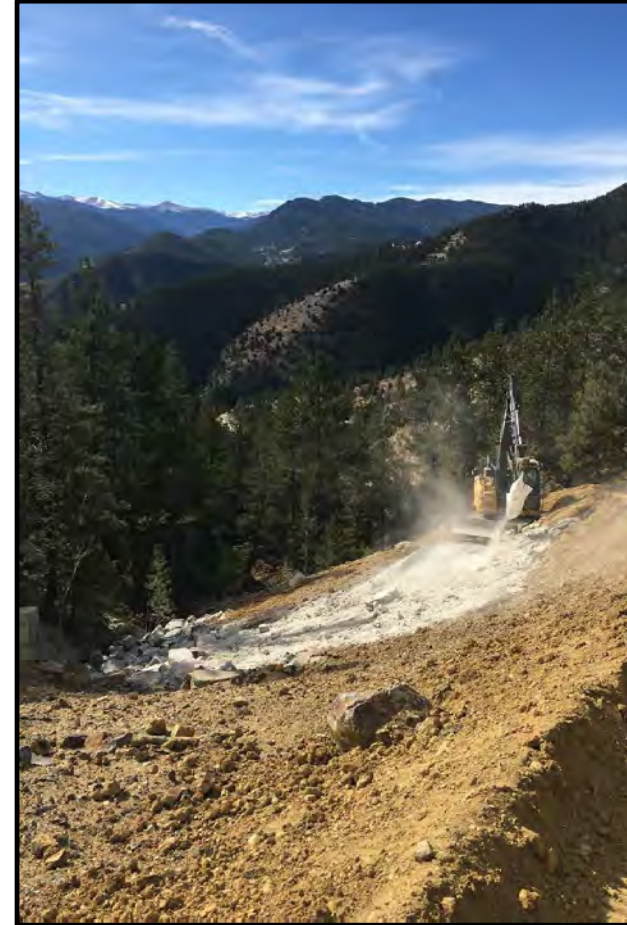
Photos # 29 , # 30 and # 31 - Transporting Crushed Limestone In Supersacs and Spreading Lime with Excavator

One hundred fifty cubic yards of compost was hauled to the site from the local sanitation department providing cost savings. Seventy five tons of pulverized limestone was brought to the site in Supersacs and transported onto the waste pile by excavator. The two amendments were uniformly combined with the mine waste into the upper twelve inches of the soil profile. **Because of the poor access, machine access is not possible and hand mixing of the compost and lime was necessary on approximately one half of the project area. This was a labor intensive and time consuming process.**

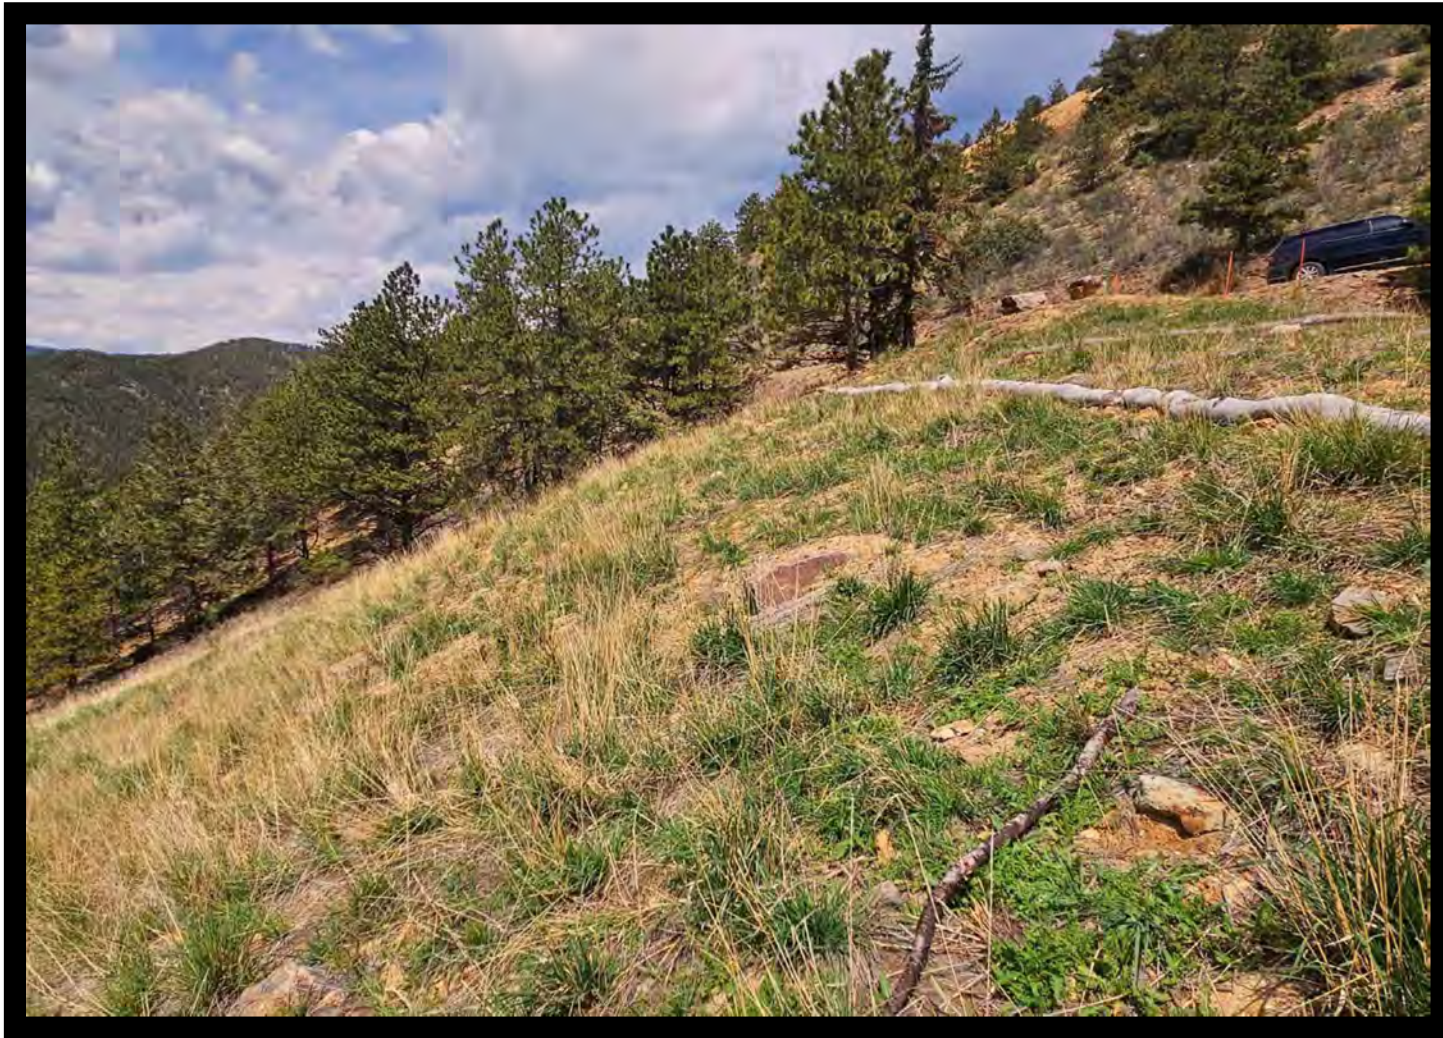
Photo # 32 - Slope 1.5 Years Post-Reclamation

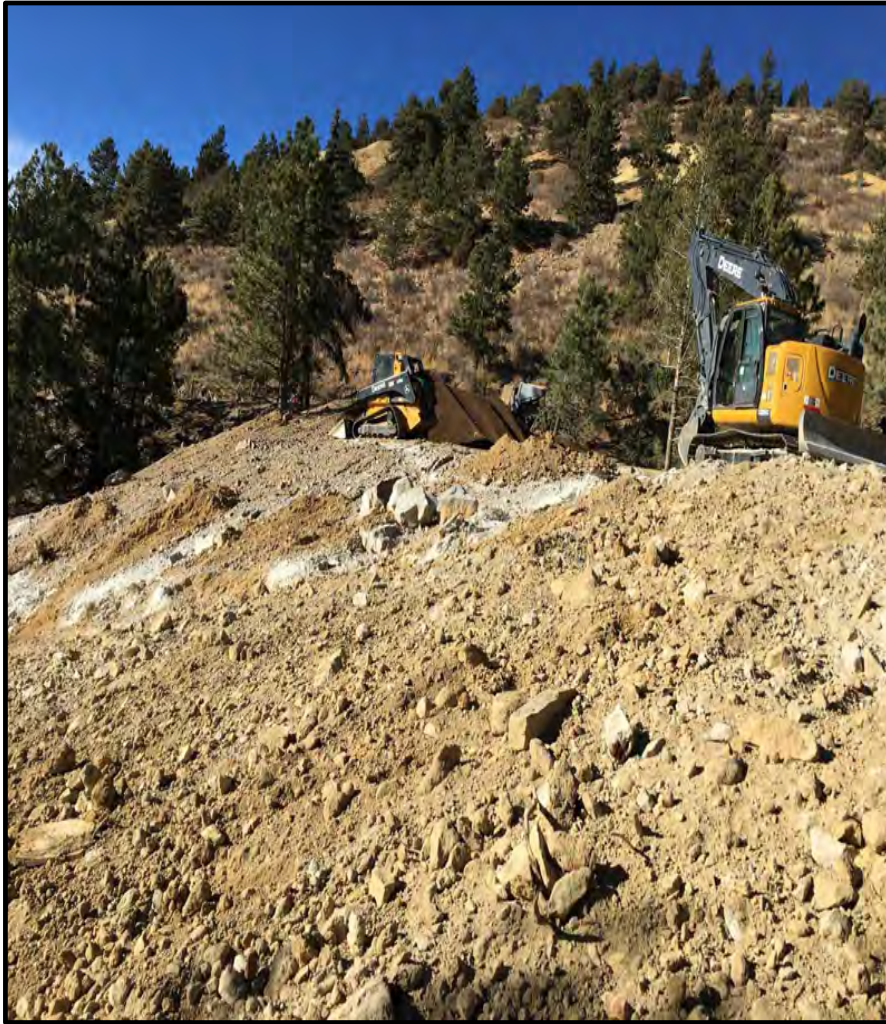
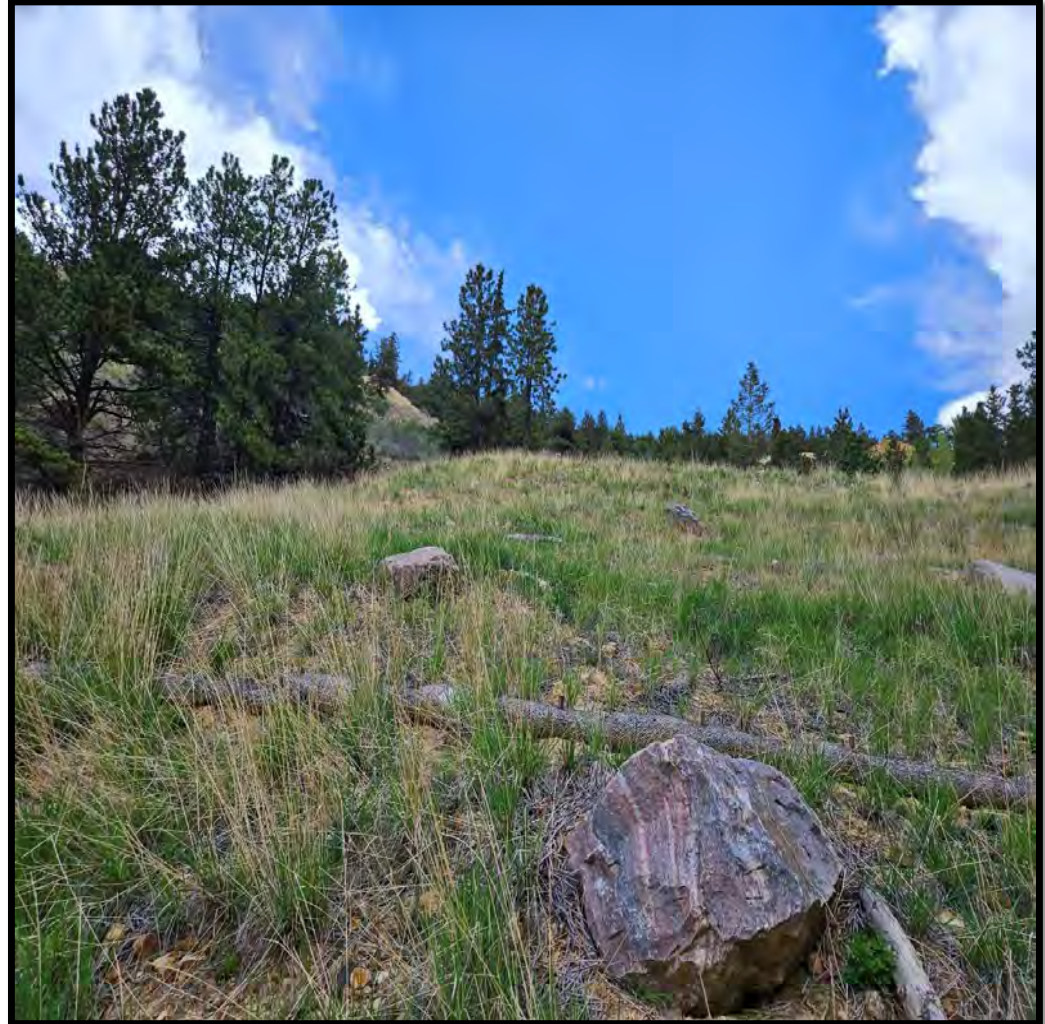
Photos # 33 & 34-Incorporating Lime and Compost with Skid Steer and Hand Labor & Slope 1.5 Years Post Reclamation

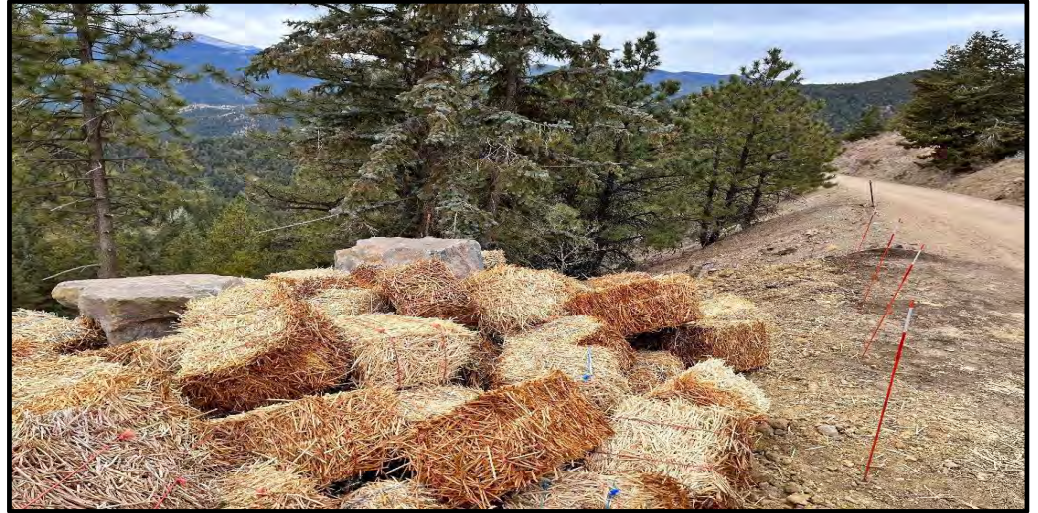
Soil Retention Blanket Installed in Upper Channel and on Portion of Slope

Due to the steep natural topography of the site, the final grade of portions of the waste pile was steeper than 2H:1V. In order to reduce erosion and aid in establishing vegetation, soil retention blanket was installed over a portion of the waste pile. The areas were seeded with a native seed mix prior to installing the blanket. In addition, over 200 linear feet of biodegradable straw wattles were installed on portions of the waste pile to reduce erosion potential.

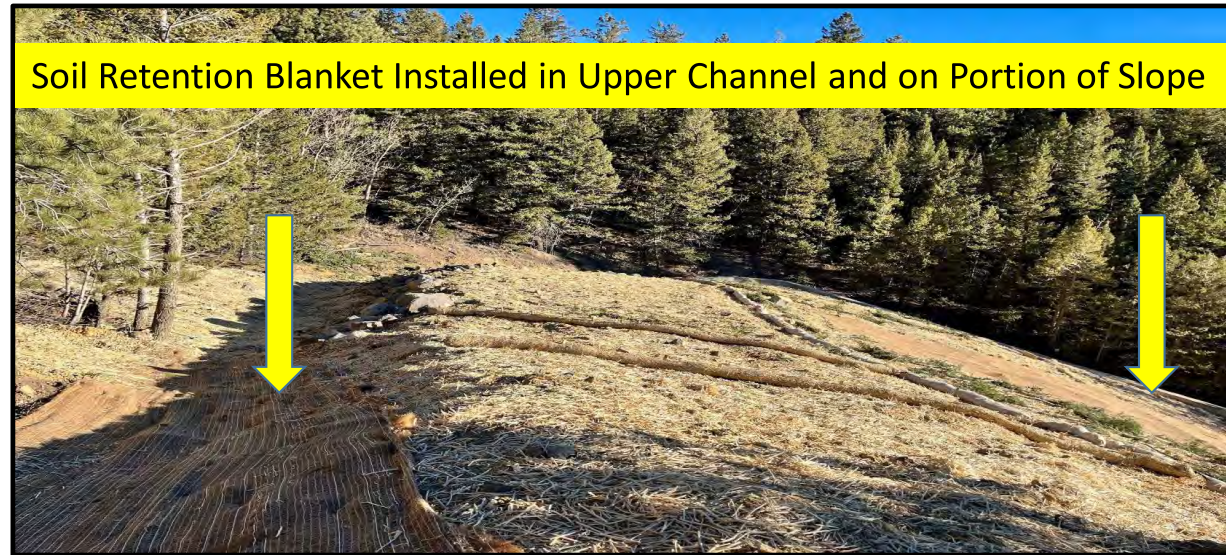
Photo # 35 , (Top) Wood Straw Mulch Bales Prior to Installation.

Photo # 36 , (Bottom) Reclaimed Slope with Soil Retention Blanket, Wood Straw Mulch and Biodegradable Straw Wattles

Following incorporation of the soil amendments, the waste pile was seeded with a native seed mix. Seed was incorporated by hand. The seeded area was then covered with a wood straw mulch which was also applied by hand. Over three tons of wood straw mulch was applied and incorporated without the aid of mechanized equipment

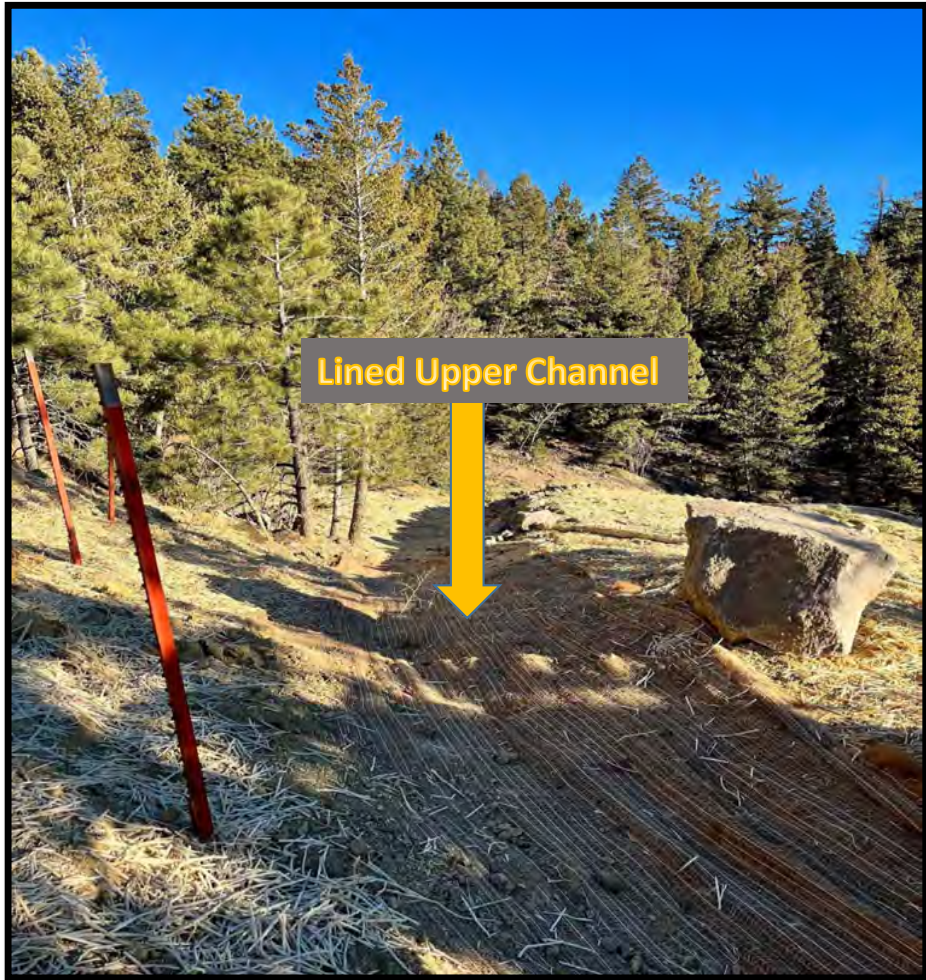
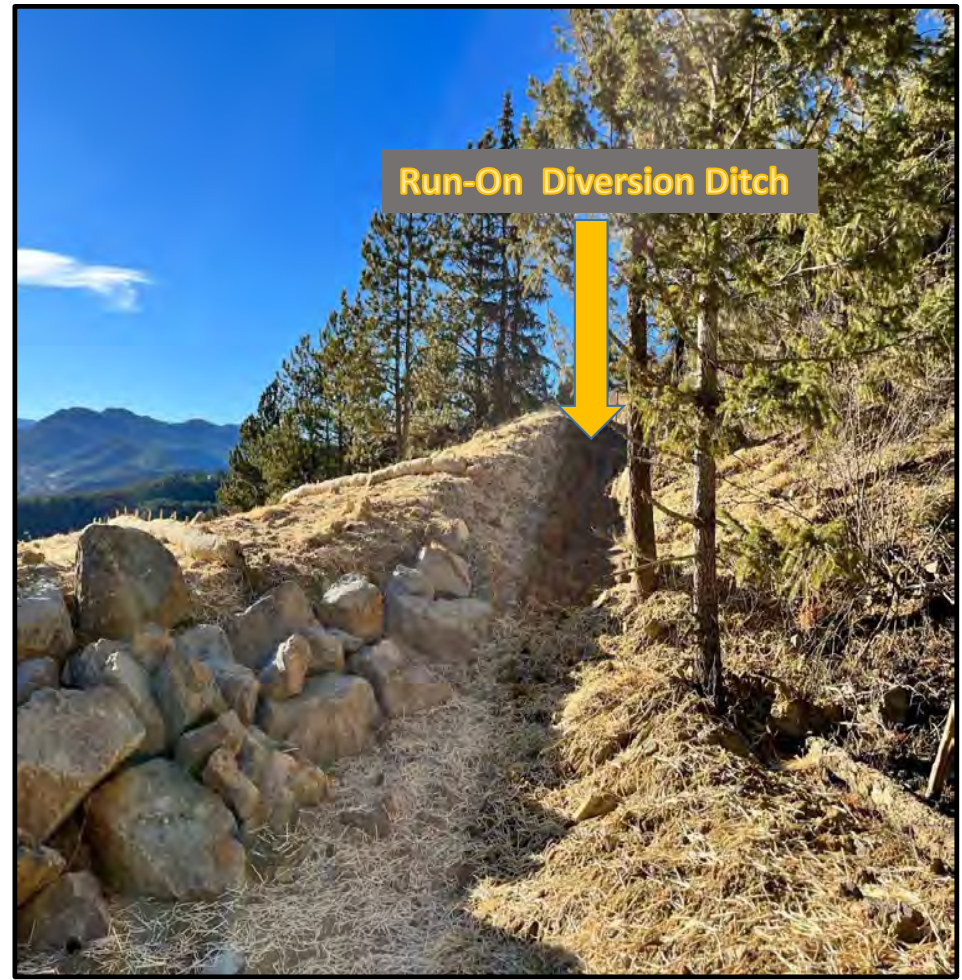
Photos # 37 & 38 -Upper Channel and Run-On Ditch to Divert Sheet Flow from Virginia Canyon Road Around Waste Pile into Lined Channel

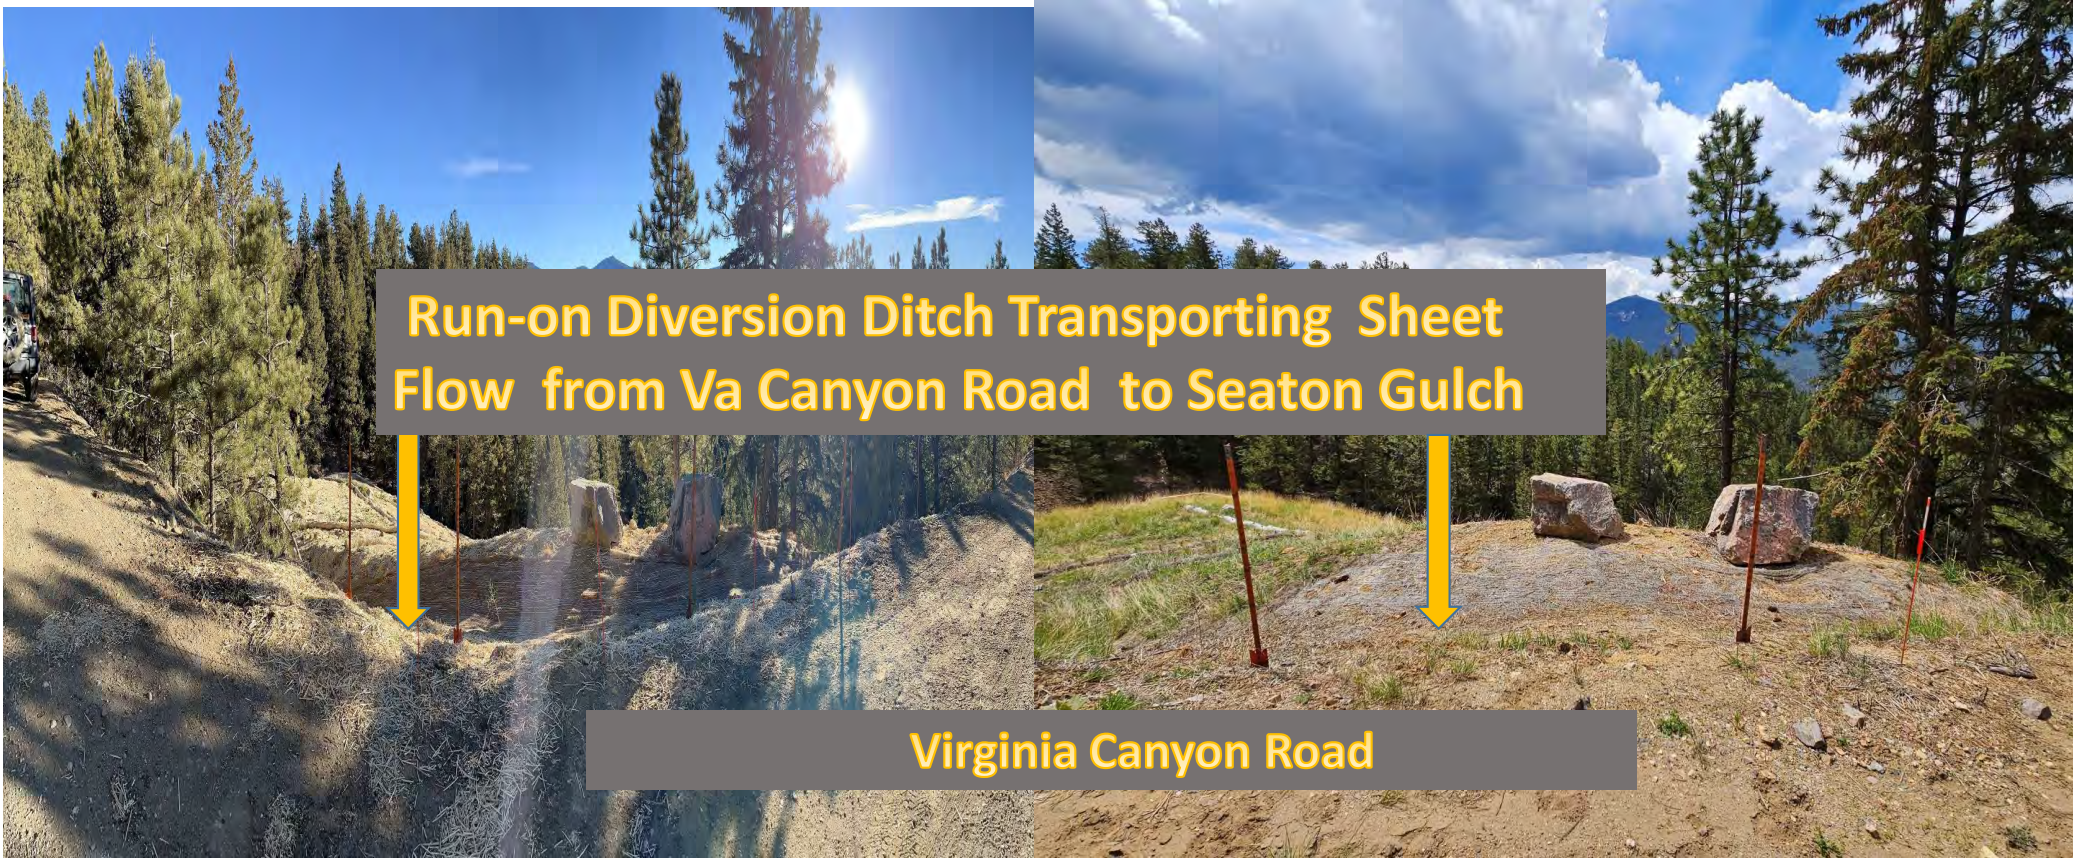
Photos # 39 & 40- Run on Diversion Ditch Pre and Post-Reclamation

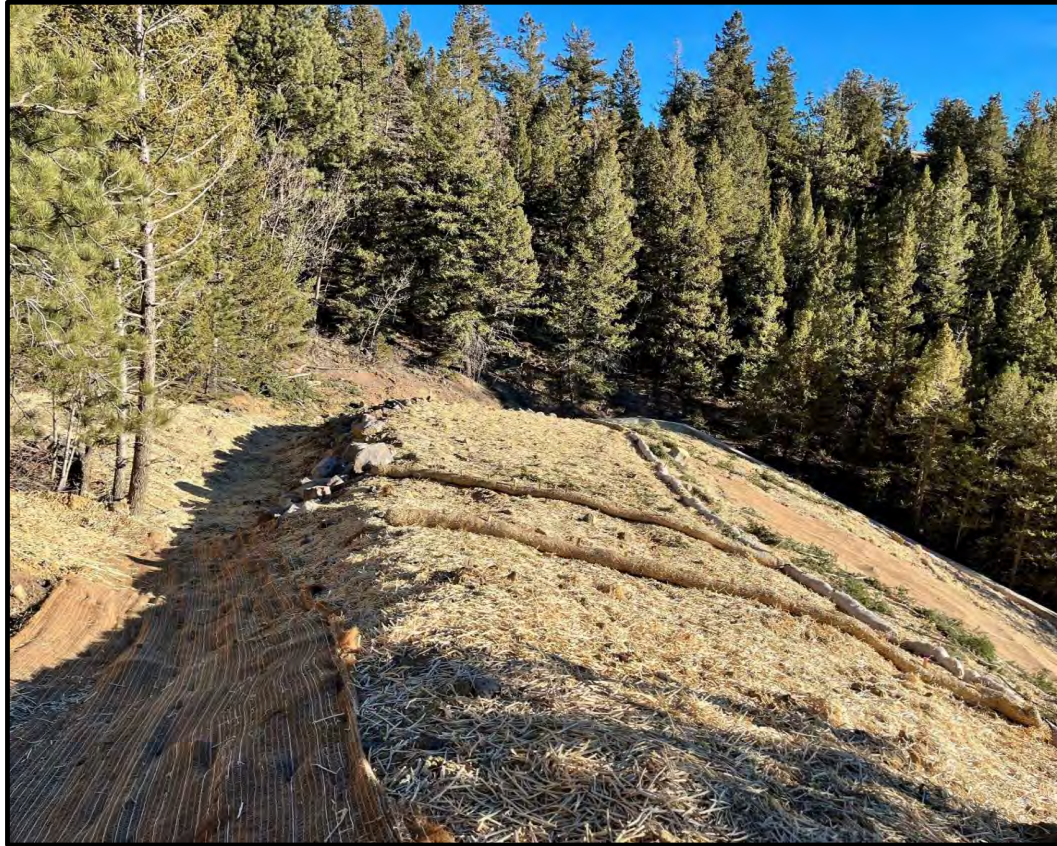
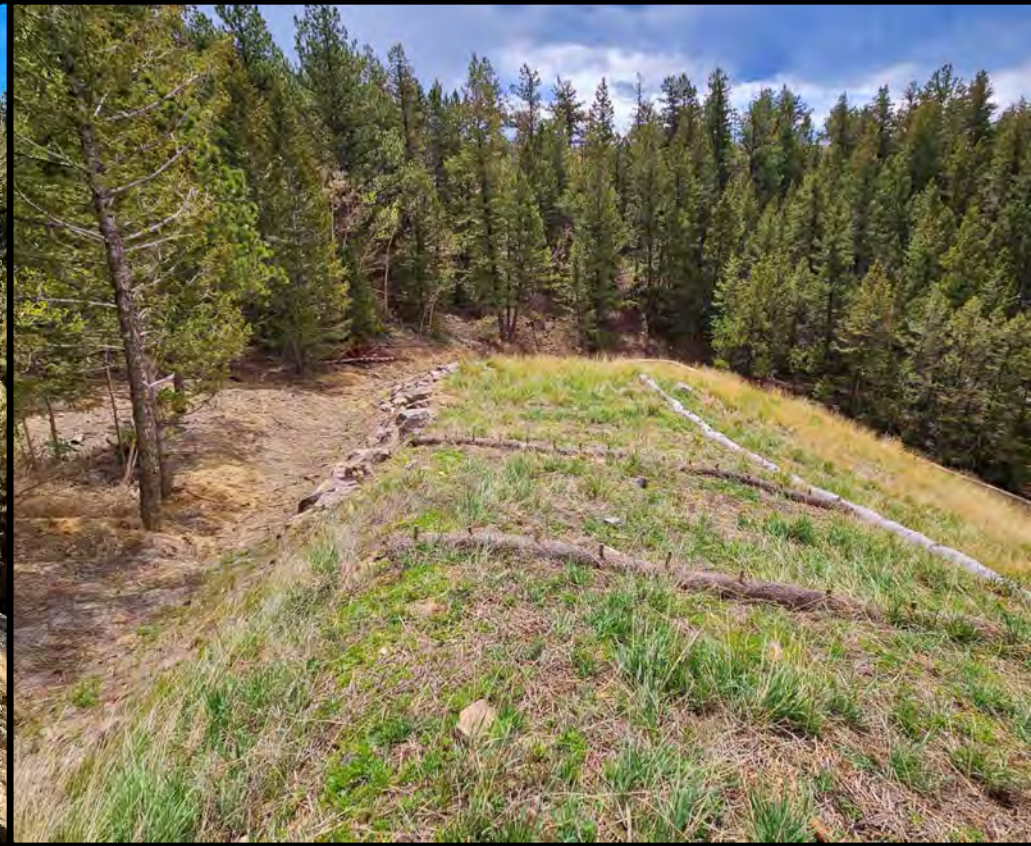
Photos # 41 & 42 - Waste Pile with Erosion Control Mat, Straw Wattles and Wood Mulch and One Year Post-Reclamation

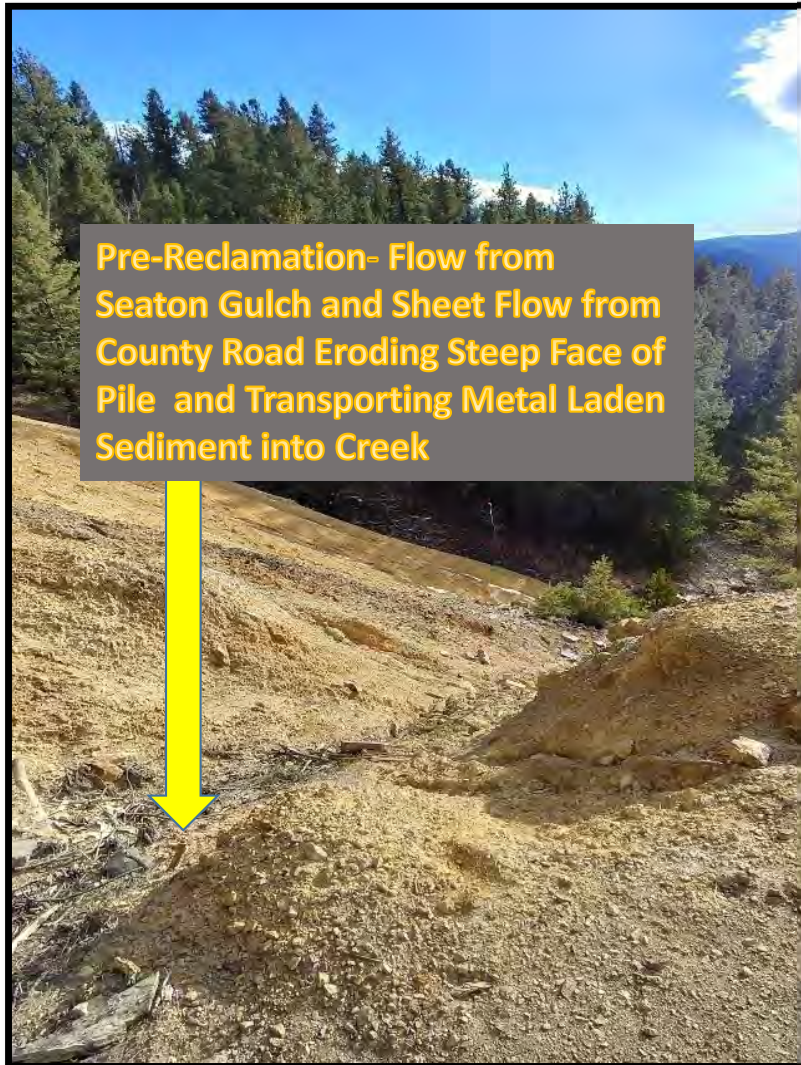
Photos # 43 & 44, Pre and Post Reclamation Flow of Seaton Gulch Same View

Pre-Reclamation- Flow from Seaton Gulch and Sheet Flow from County Road Eroding Steep Face of Pile and Transporting Metal Laden Sediment into Creek

The Casino mine waste pile is located directly adjacent to Seaton Gulch, a tributary to Clear Creek. Prior to reclamation, a culvert located on Virginia Canyon road directed drainage onto the waste pile and actively eroded the mine waste into Seaton Gulch. Deep gullies were cut in the face of the pile and sediment eroded from the pile into the adjacent drainage during storm events and spring runoff. Also, fugitive dust containing heavy metals emanated from the area. Several residences are in relatively close proximity to the site and many tourists travel Virginia Canyon Road. Virginia Canyon is a very popular mountain biking destination and fugitive dust may greatly impacts riders. Recent assessments of the area indicate that some of the mine waste piles in Virginia Canyon may pose an unacceptable human health risk to local residents living in the area due to heavy metals.

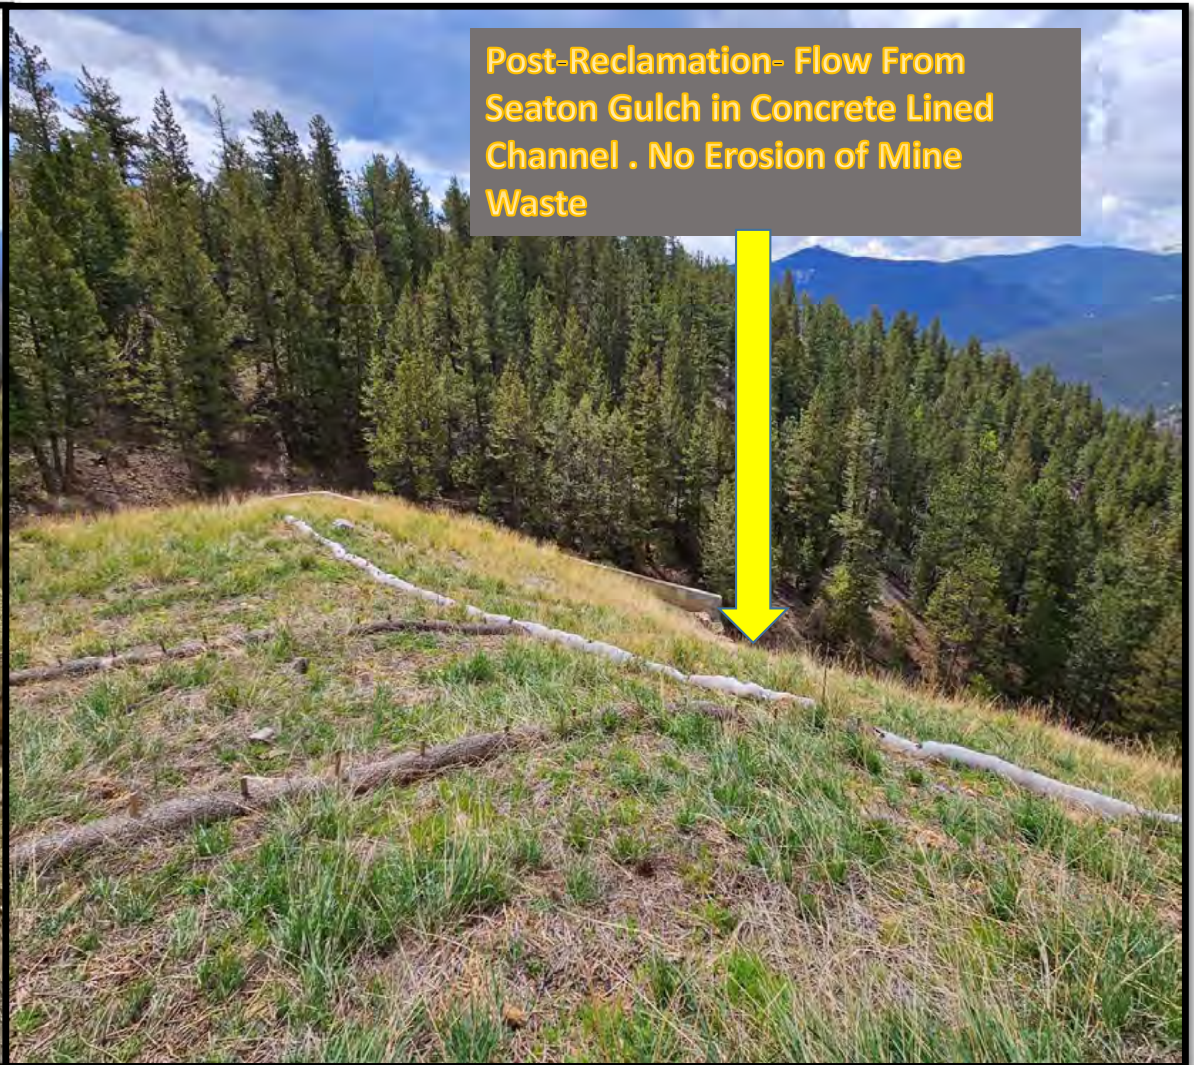
Post-Reclamation- Flow From Seaton Gulch in Concrete Lined Channel . No Erosion of Mine Waste

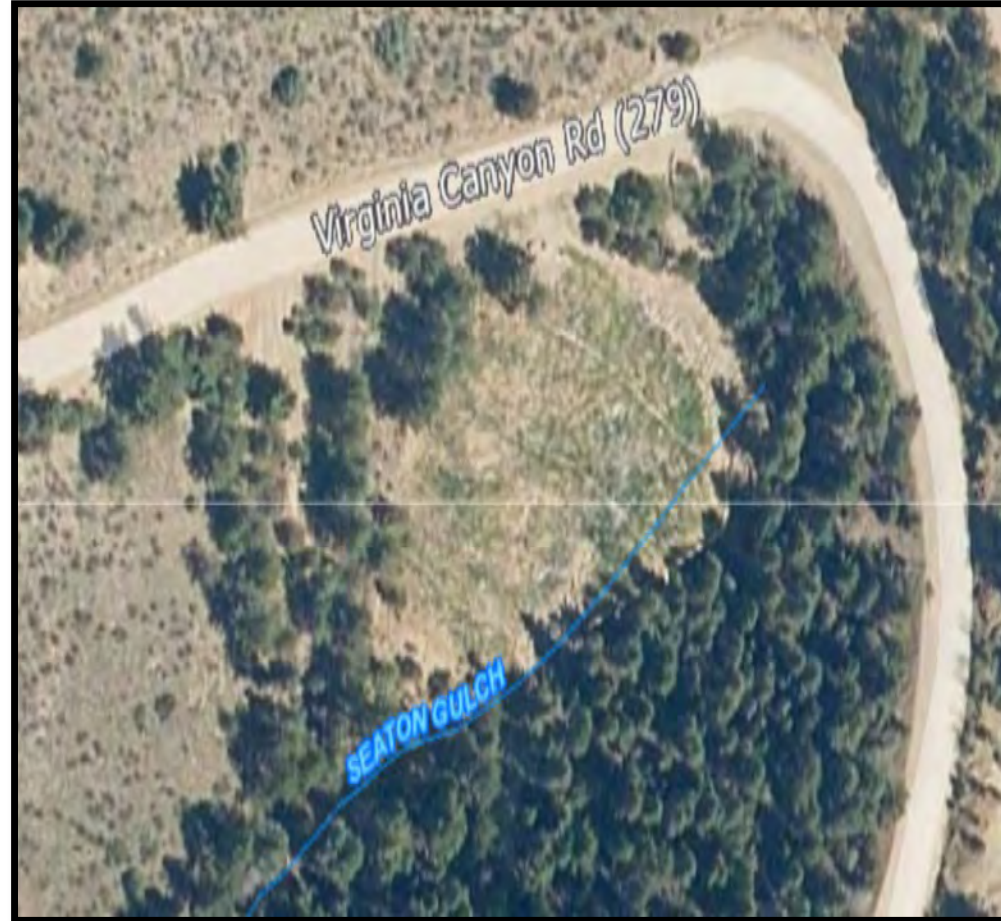
Casino Mine One Year Post-Reclamation-Gullies Removed. Site Stable & Revegetated (2022)—Image from Clear Creek County Website

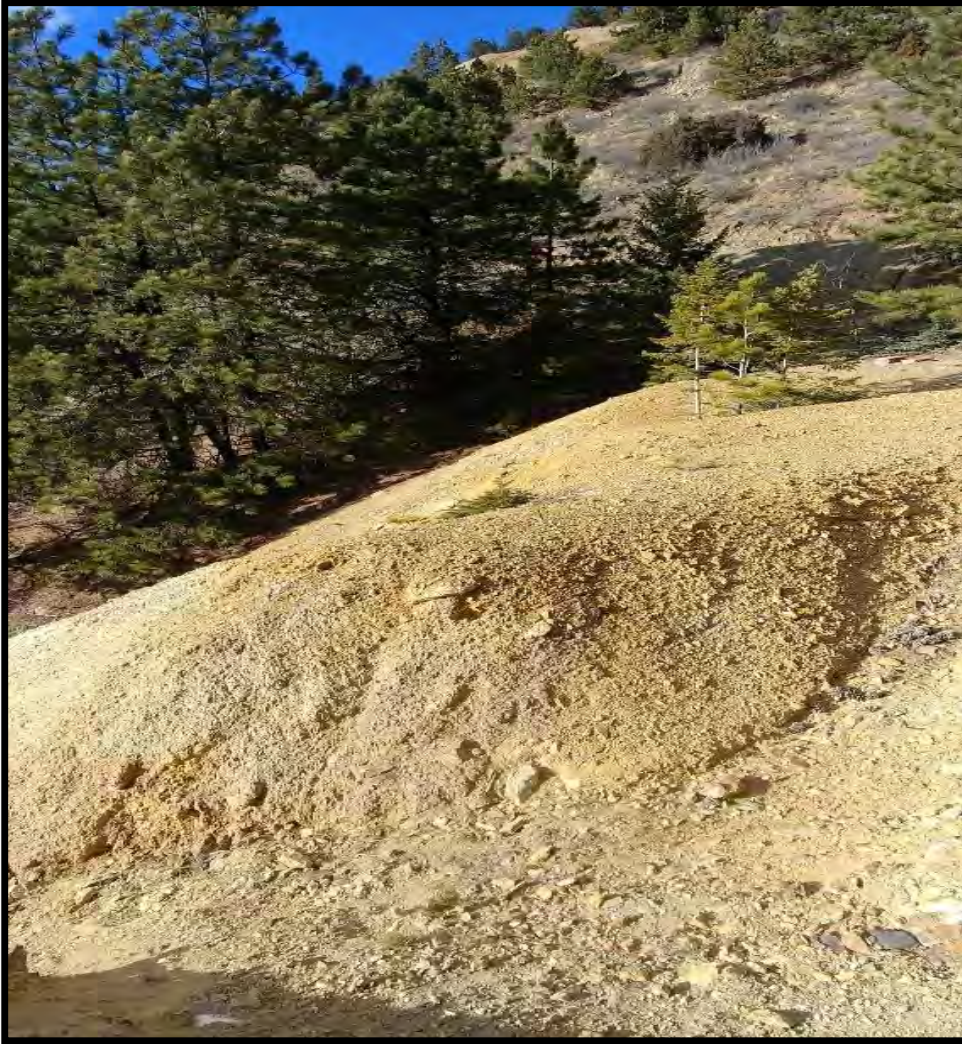
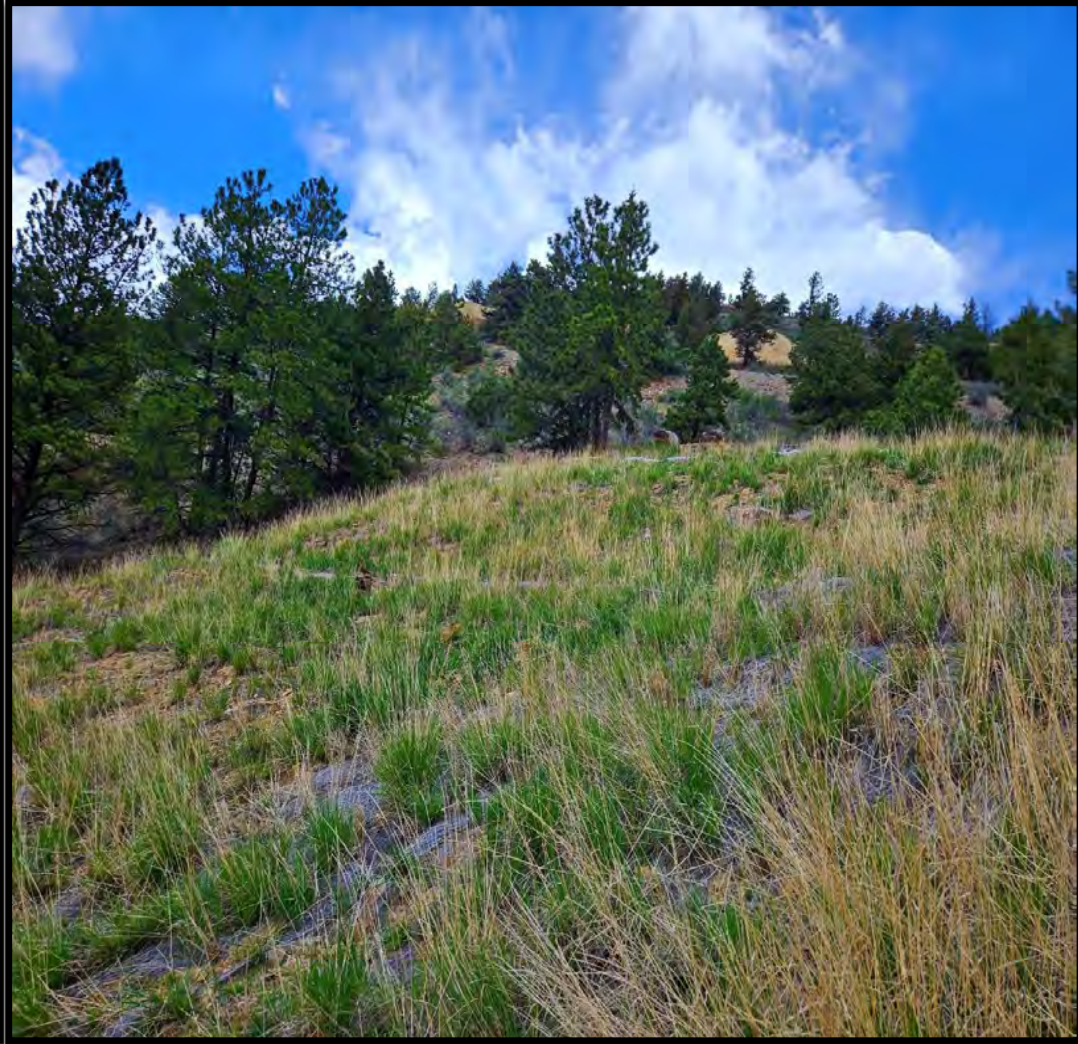
Photos # 45 & 46 , Prior to Reclamation and Reclaimed Slope of Waste Pile
